**Kentucky Stormwater Association - 2017
Utilizing Urban Trees for Stormwater Management**

An Evaluation
of Root Growth
Patterns

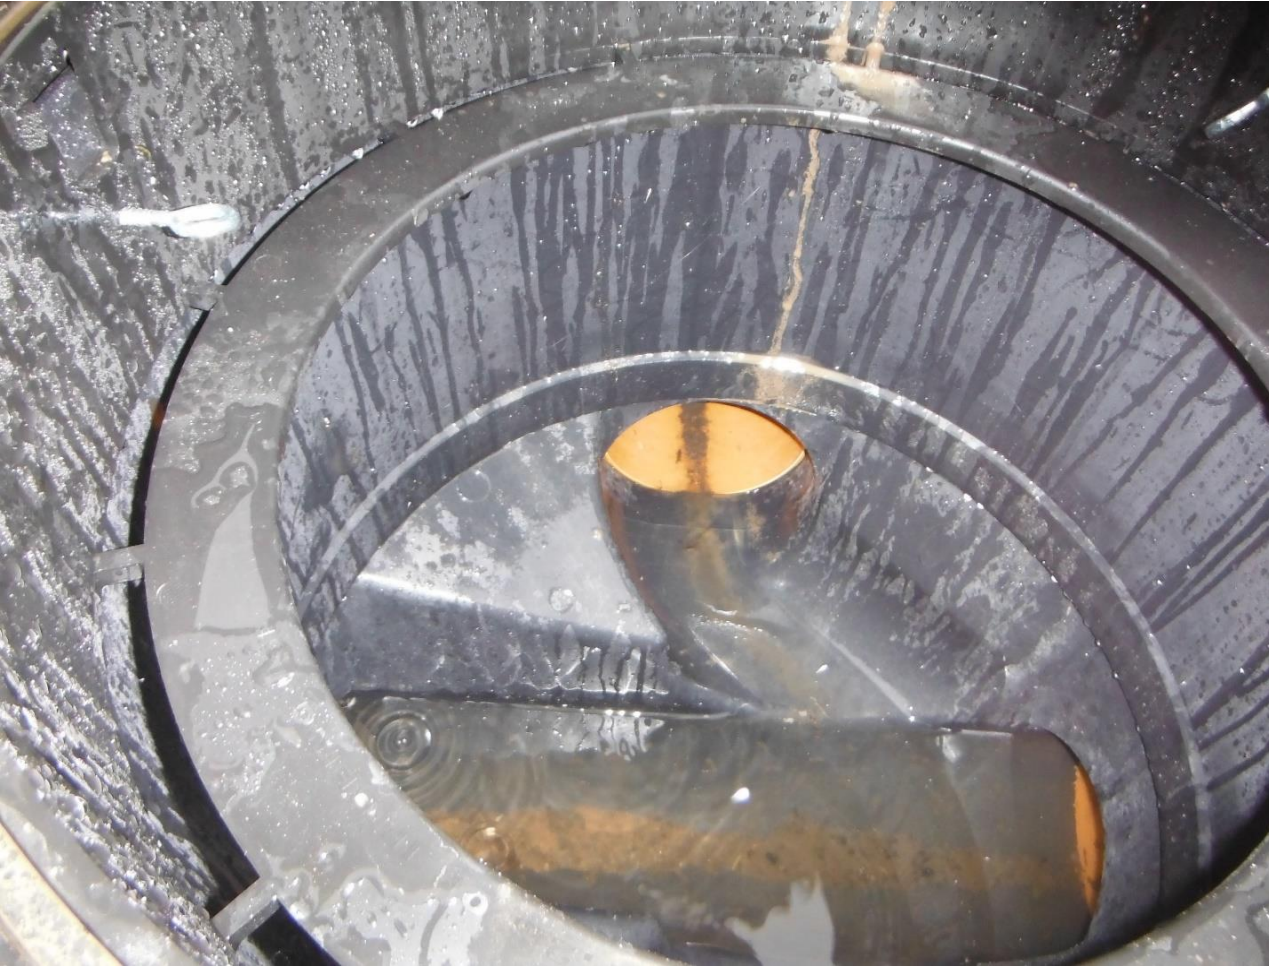
DSCF0323 - Water flowing into the system from parking lot strip drain.

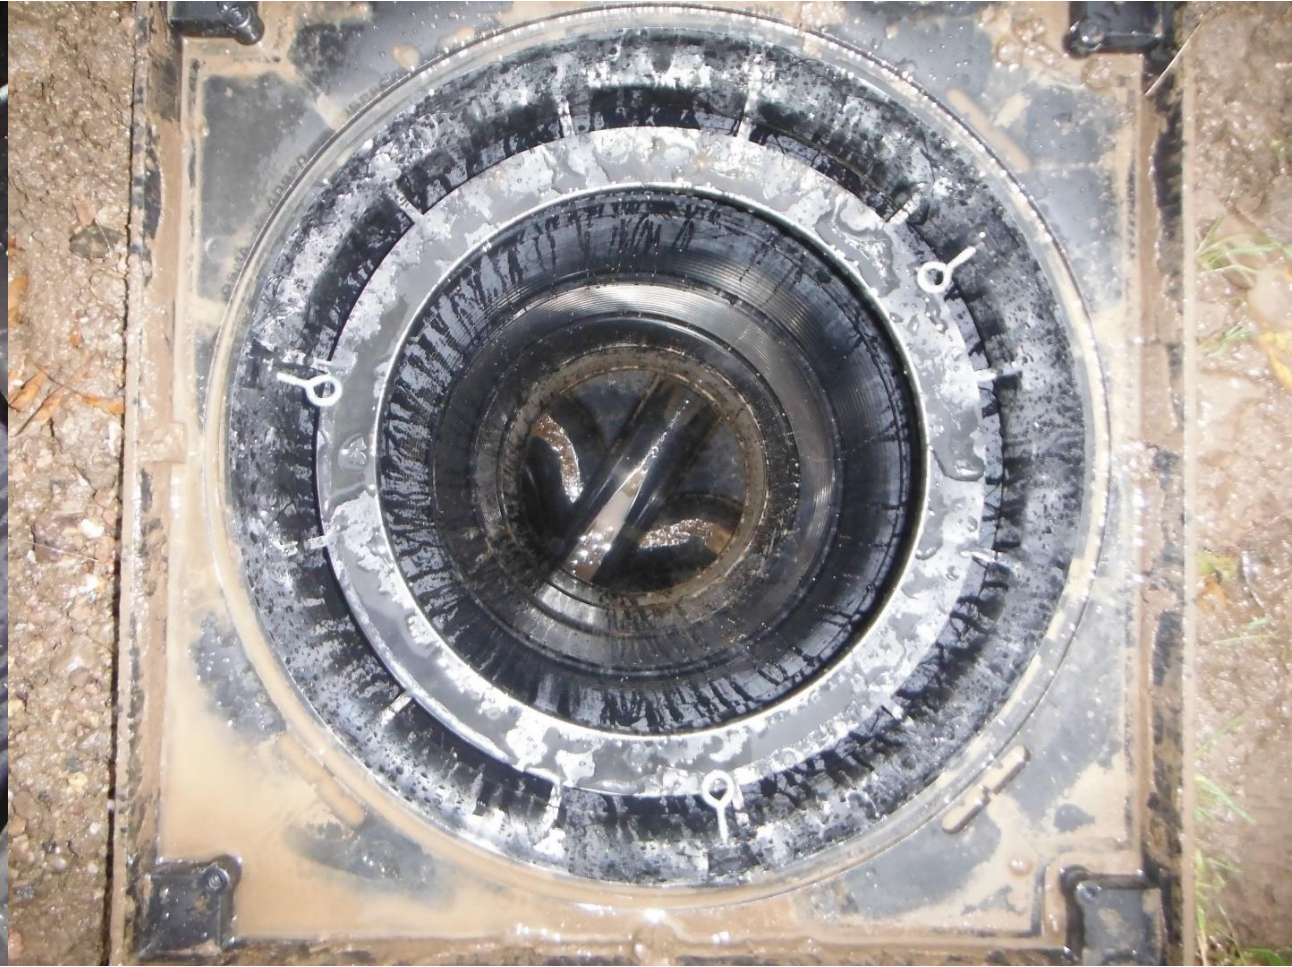
DSCF0319 - shows outlet drain - no water flow outwards after 2 hours of rain fall, demonstrating attenuation in action. Some post installation debris visible. This is 80" (2m) down.

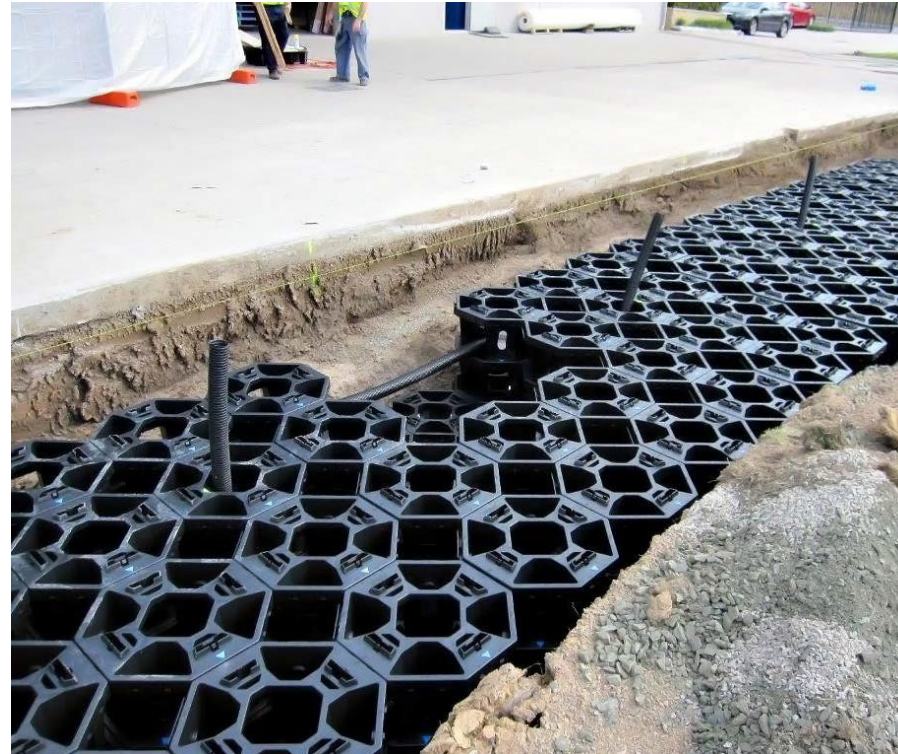
Figure 9 shows the initial Stratacell layers being installed in 2011. Note the depth of concrete on one side, and RootRain piping incorporated into the Stratacells.

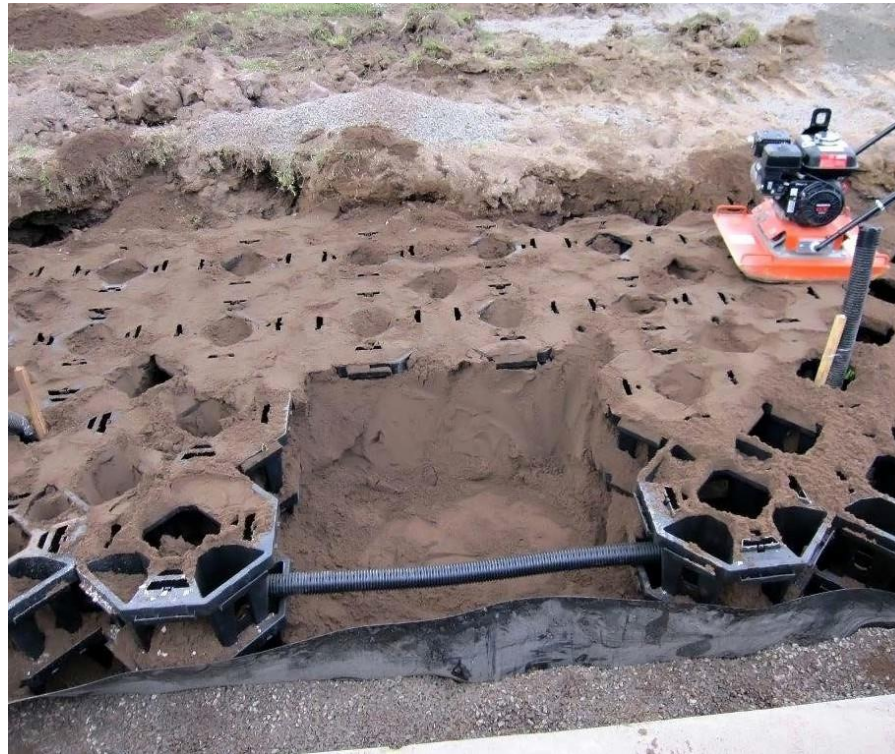
Figure 10 shows the backfilling of the Stratacells with sandy loam growing media and compaction. A root barrier has been placed between the Stratacells and the concrete forecourt with a strip of fine gravel approximately 250 mm wide placed against the concrete to minimize root invasion. The planting hole is prepared and ready for completion.

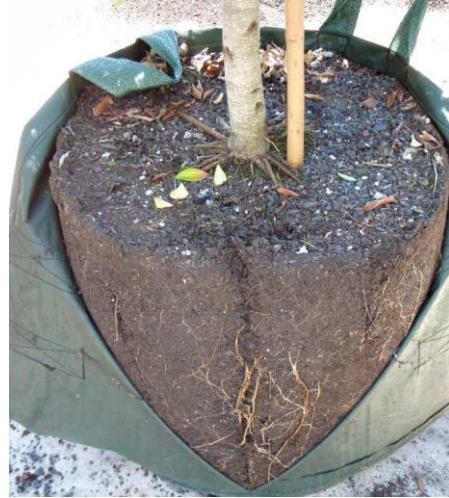
Figure 5 is an image of a typical rootball grown to NATSPEC produced by Trees Impact (Ross Clarke 2015).

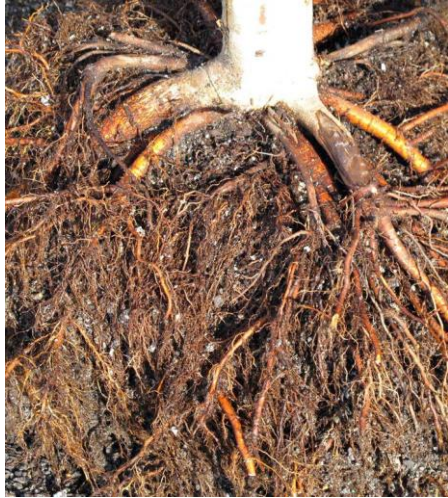
Figure 6 shows the initial distribution of roots through high water pressure removal of growing media. The NATSPEC criteria ensure trees develop a high degree of root division, rootball occupancy and no root girdling. (Jim 2015)

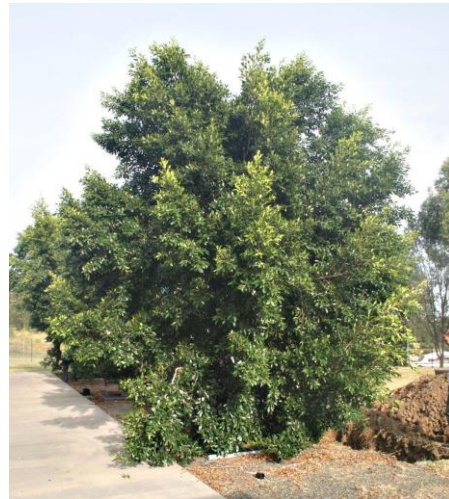
Figure 7 shows the view looking west at the commencement of excavation. The dense canopy of the Figs extended to ground level. Tree 1 had achieved 6m in height and 5 metres in width in a 4 year period.

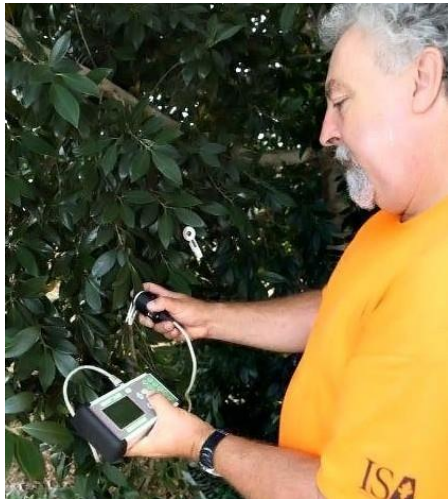
Figure 8 - Using the Handy PEA fluorimeter to measure chlorophyll fluorescence values.

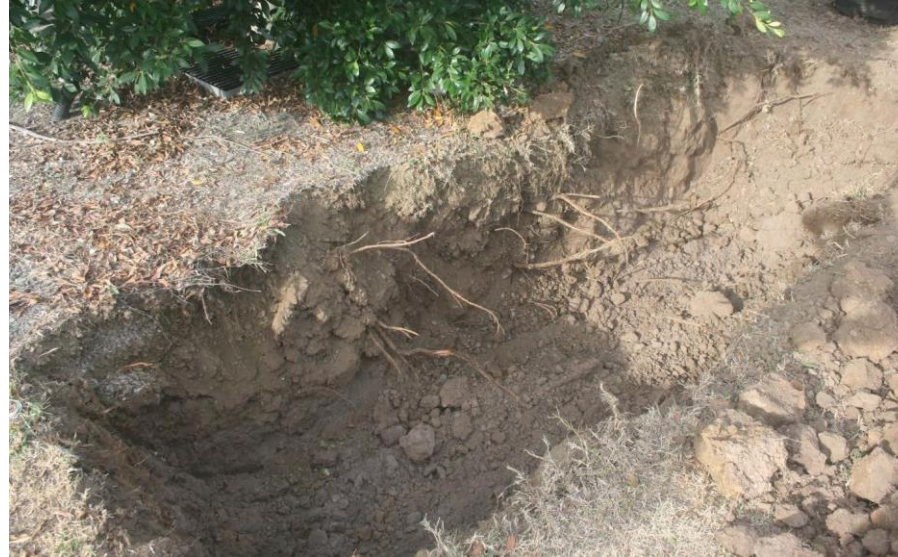
Figure 3 shows the first trench excavated, exposing the edge of the tree vault system. The trench edge was 1.6 metres from the trunk on this side. Note the presence of roots (15 – 25 mm diameter) found at the edge of the vault.

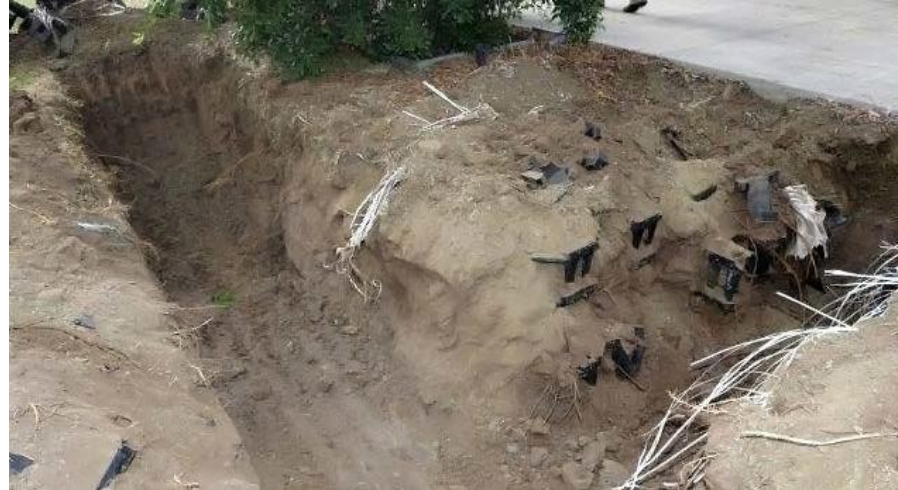
Figure 11 shows the view looking at the trenches excavated about Tree 1 with some of the exposed Stratacells and Root Grid.

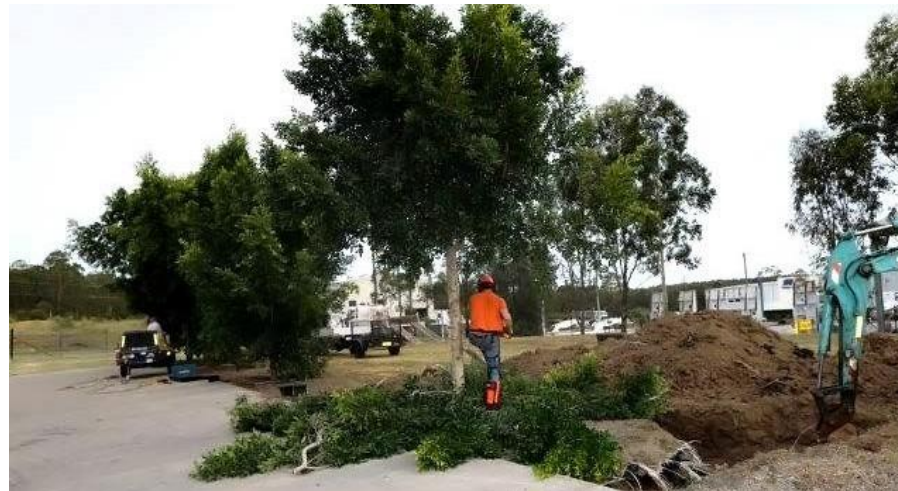
Figure 12 - removing the canopy to permit access for further work.

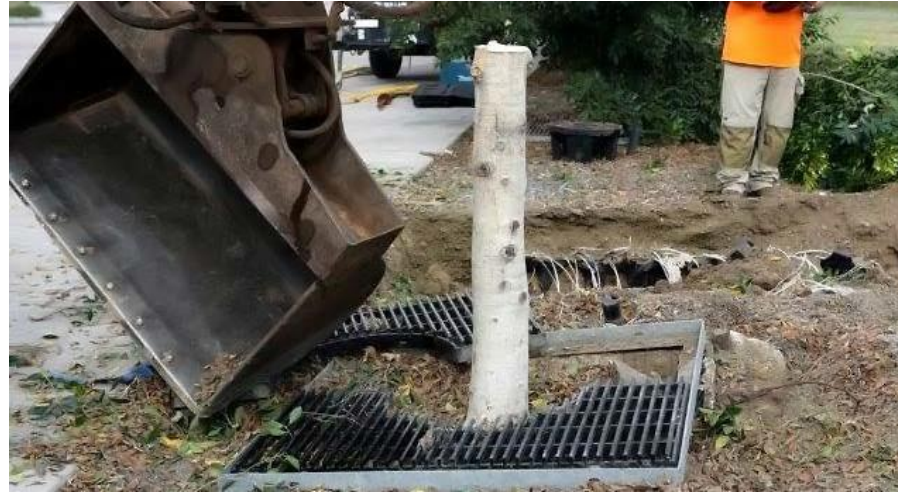
Figure 13 - the canopy has been removed and the excavator dismantles the tree grate system. The RootRain piping is partially exposed.

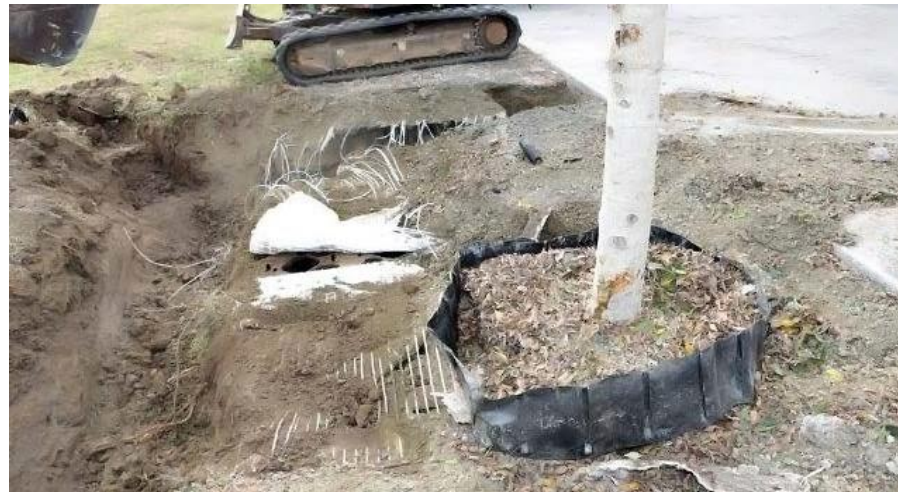
Figure 14 - using the excavator to remove the uppermost layer of gravel and expose the Ribbed linear root barrier.

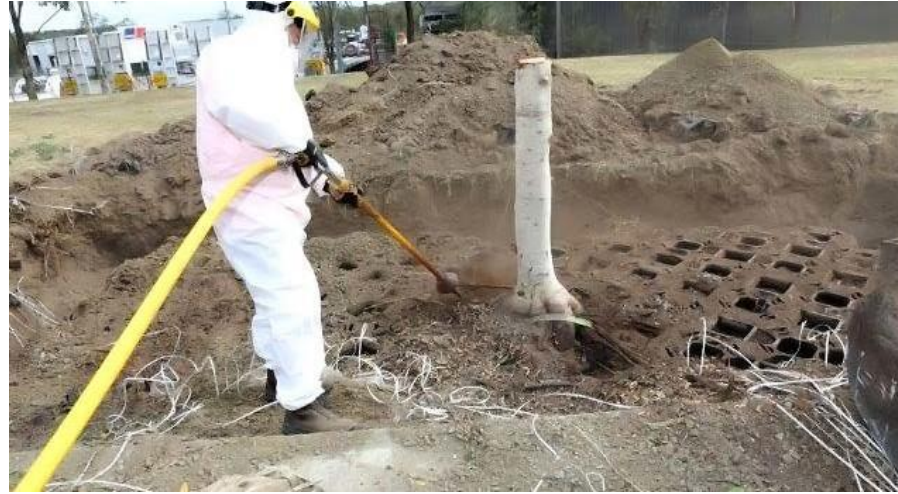
Figure 15 - with the Root Grid membrane and ReRoot linear barrier removed, air excavation commenced to start to unveil root growth.

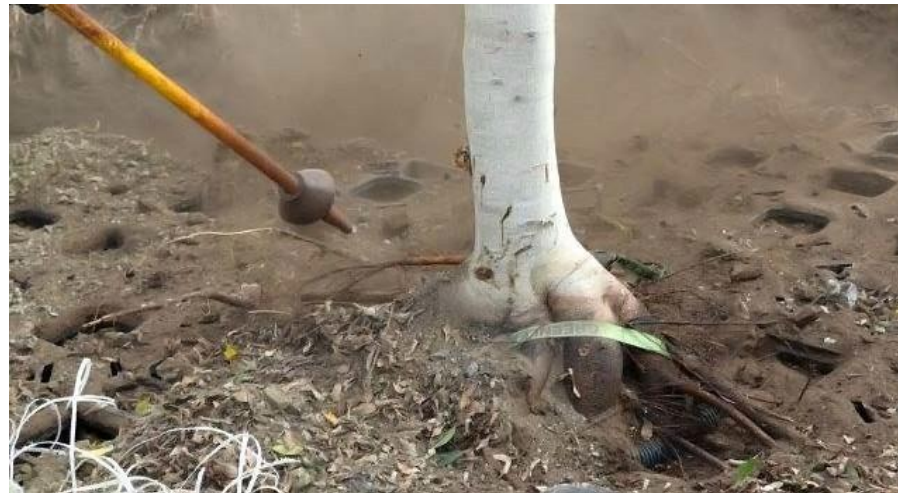
Figure 16 -the high pressure air easily exposes the first layer of Stratacells and the initial root crown.

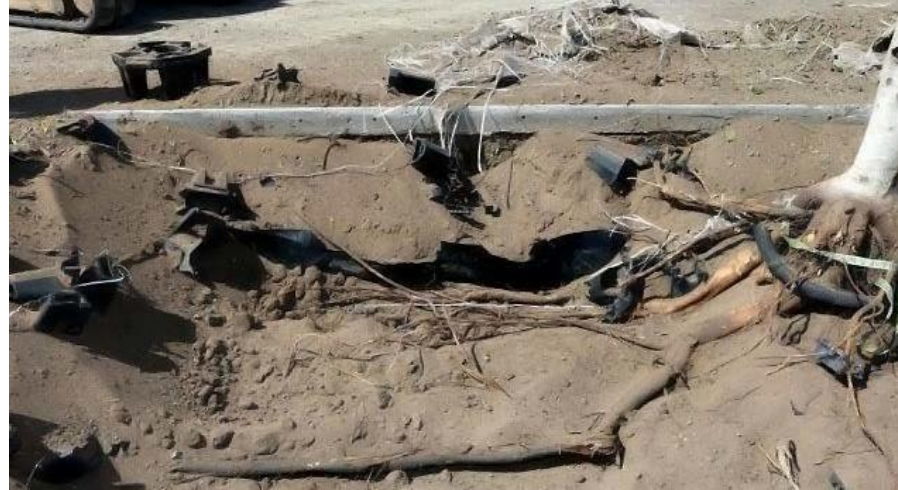
Figure 19 - excavation by air and machine expose roots that have descended to a depth of 700 mm then spread through the Stratacell voids in a linear fashion.

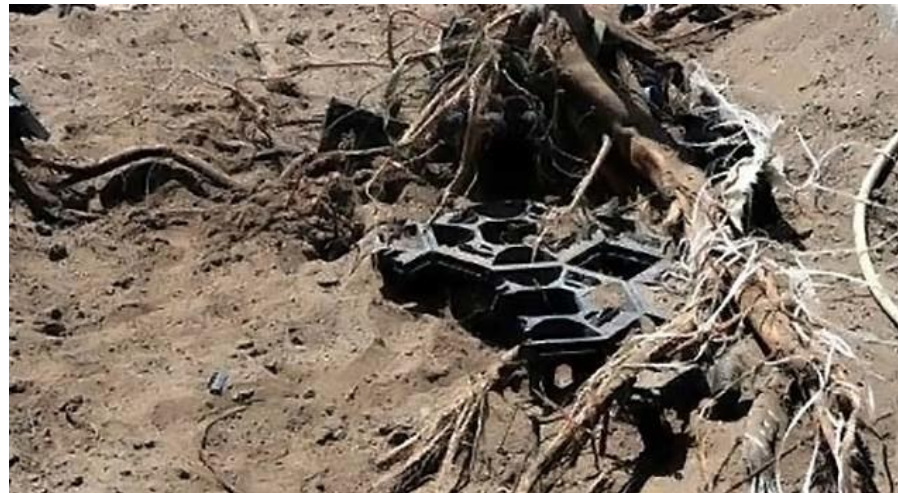
Figure 20 - this image shows how the roots grew in several directions. The majority of root development was parallel to the edge of the concrete. Large roots were present just above the RootRain pipes. Other roots grew at 90 degrees to the root barriers and concrete edge. Most lateral spreading roots were present at a depth of 600 – 700 mm or lower.

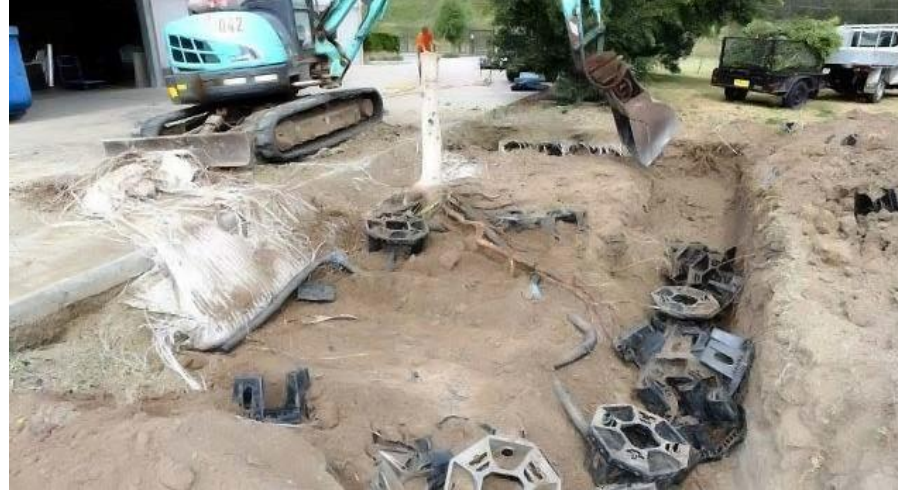
Figure 17 - the first insight into the patterns of root growth in the Stratacells is revealed once the first layer is mechanically removed. In some cases, Stratacells had to be cut away as roots had penetrated the cells.

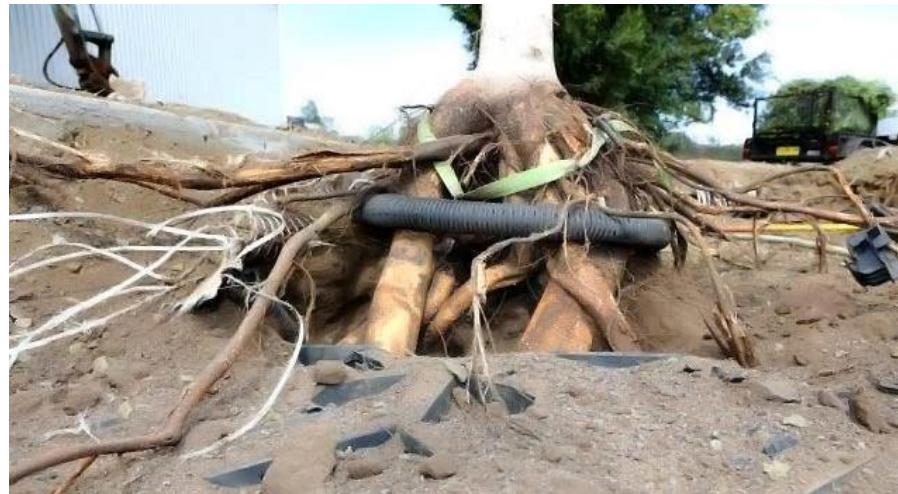
Figure 18 clearly shows the downward initial root growth caused by ReRoot linear barrier. The Root-Rain Piping and security straps did their job. The diameter and number of roots present was observed as well as the deep penetration of roots.

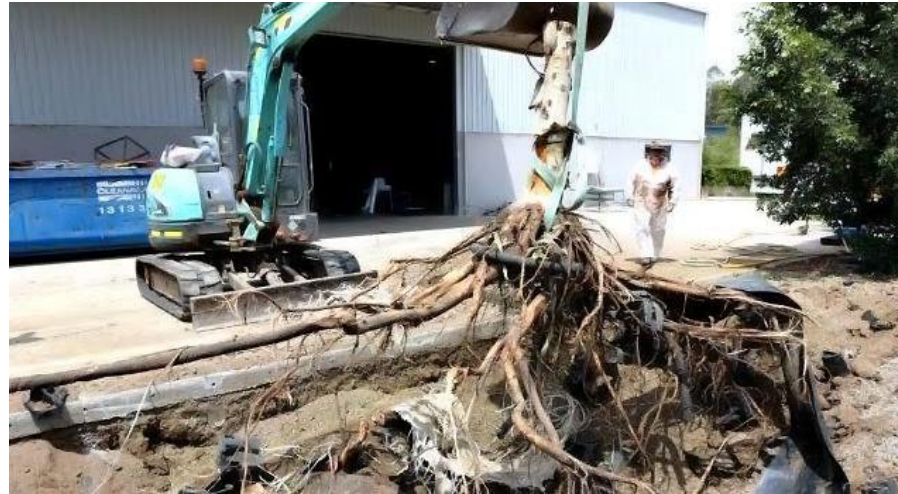
Figure 21 - after considerable mechanical excavation occurred, the final root system was removed, complete with root barrier, sections of RootRain and Stratacells where roots had grown well through the layers.

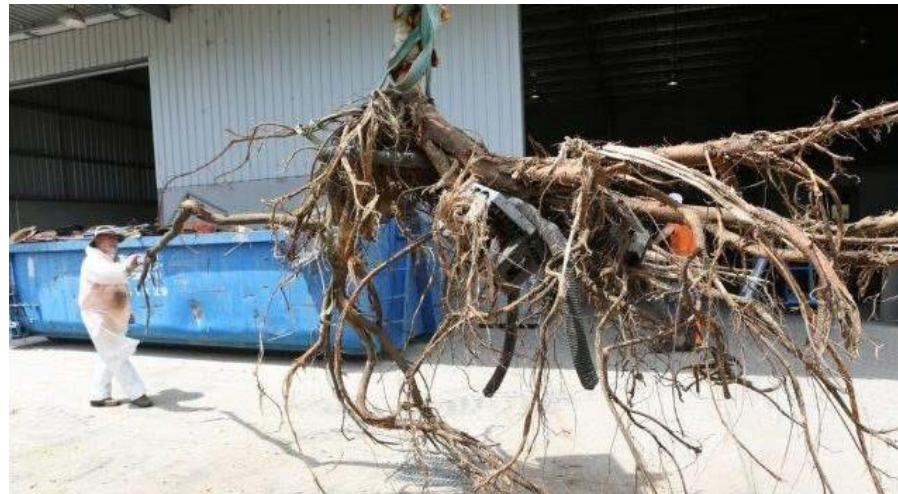
Figure 22 - the complete root system excavated minus a few lateral roots that broke off. The roots were found to a depth exceeding 1.8 metres and had a spread exceeding 4 metres in all directions.
