# Cost-Effective Stormwater Management for City Streets

Kentucky Stormwater Association

June 27, 2019

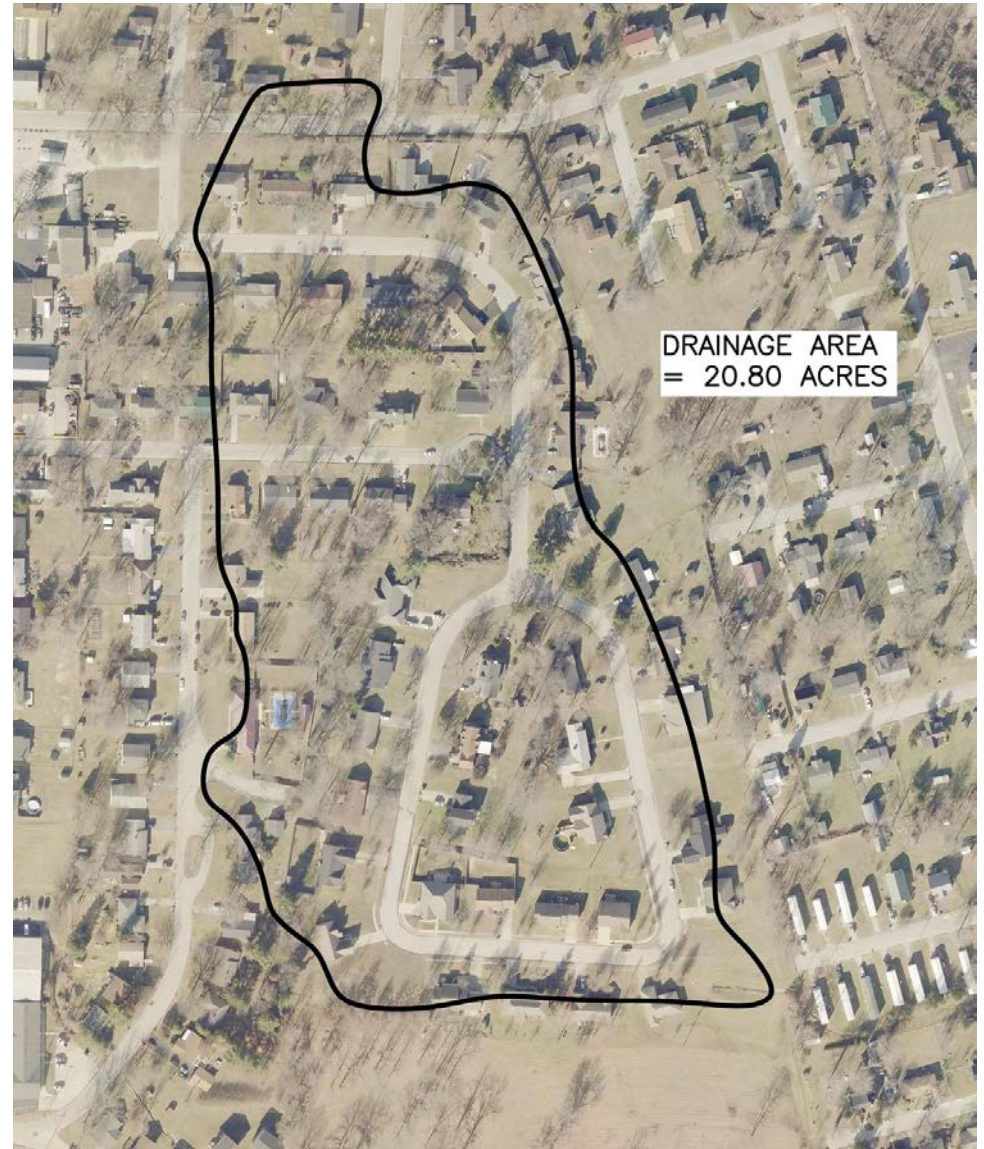
# Problem Definition

- Berea soils – decomposed New Albany Shale (clay-like)
- Watershed: 21 acres of overland ~ ½ mile travel
- Flat surface slopes
- Assumption: Poor subgrade drainage leads to pavement deterioration
- No budget for storm sewers

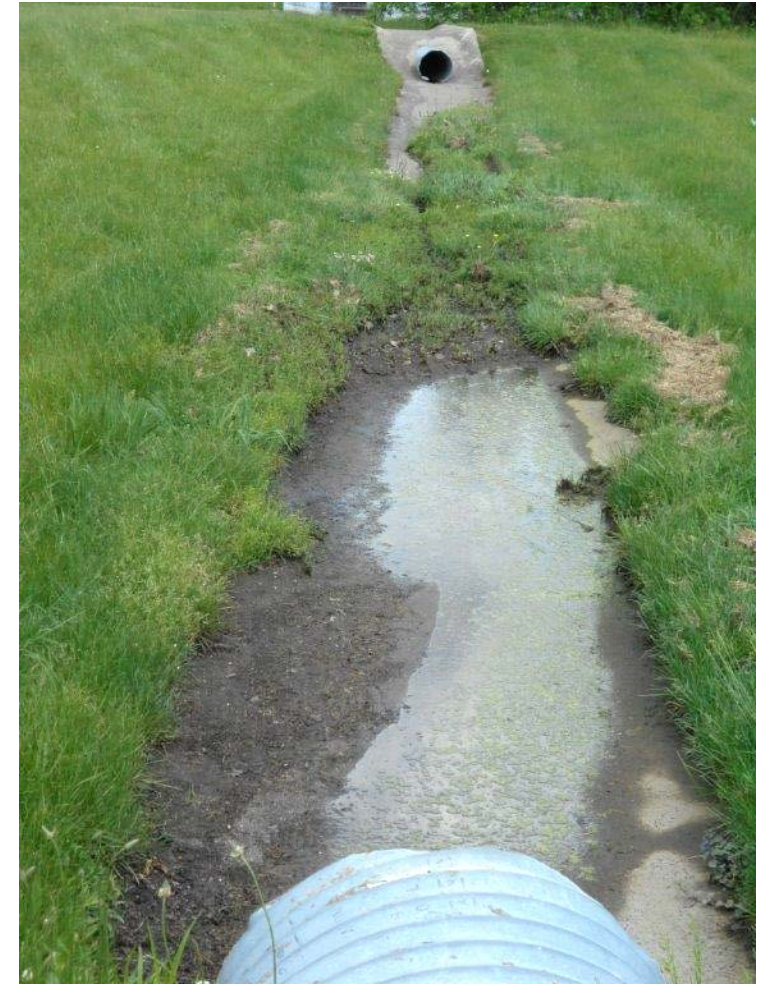
Downstream detention basin: future retrofit to improve WQ

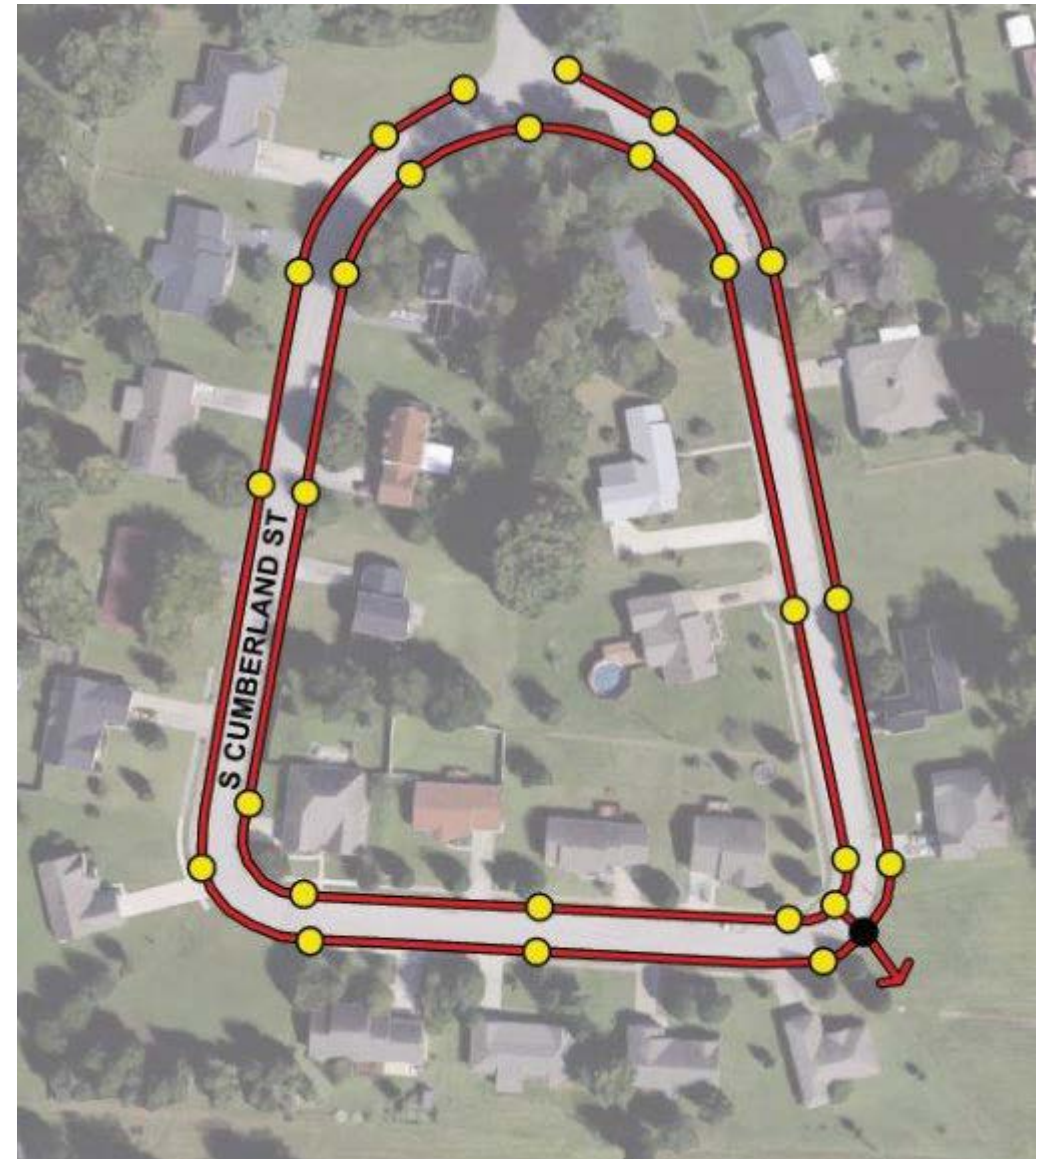
# Design Considerations

- Perforated pipe UD system to extend pavement life
- Frequent surface inlets for maintenance access
- No design storm – surface flow interception is “gravy”
- 3,560' - 8" perforated pipe, 26 inlets
- Cost-effective materials

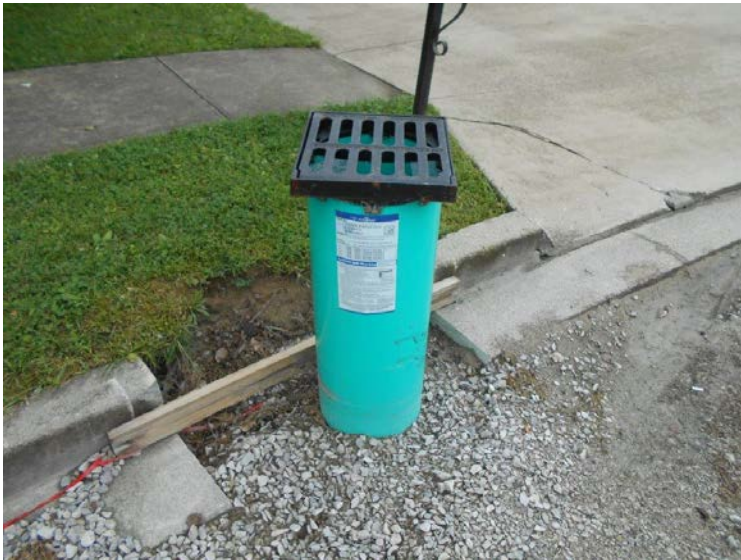
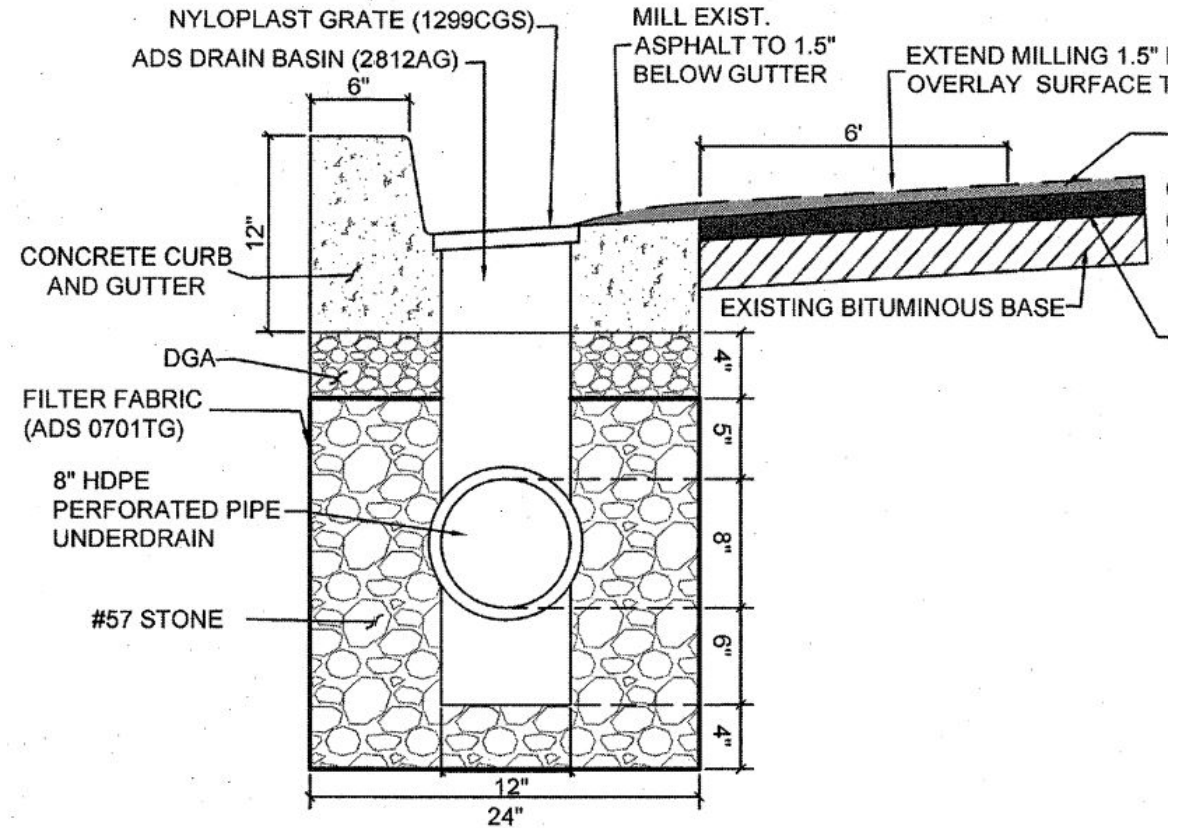
STORM INLET AND DRAIN, PAVING AND MILLING - DETAIL A

# Design Details – North Section

- UD under gutter
- Replace C&G, some driveway aprons
- Mill & overlay

N.T.S.

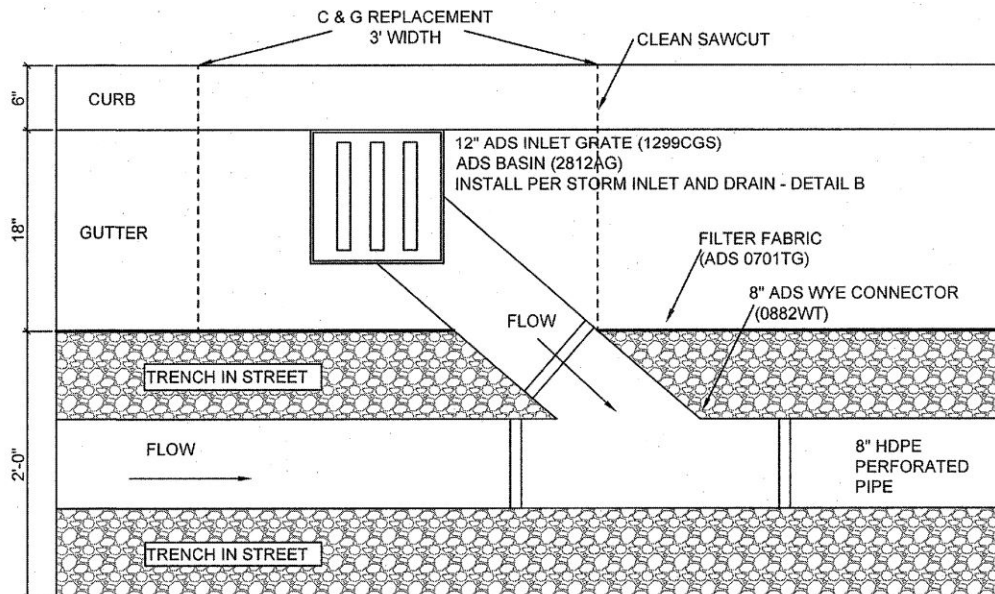
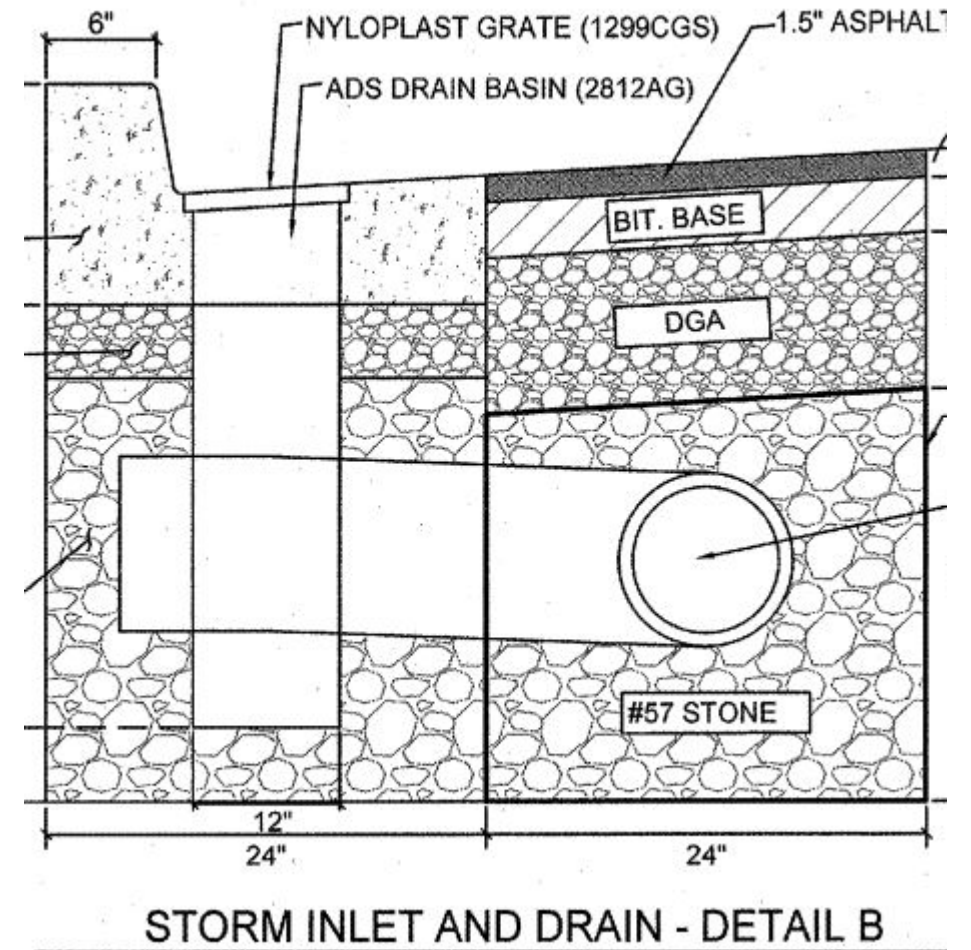
# Design Details – South Section

- UD in street
- Connect to existing CBI
- Replace C&G at inlets
- Mill & overlay

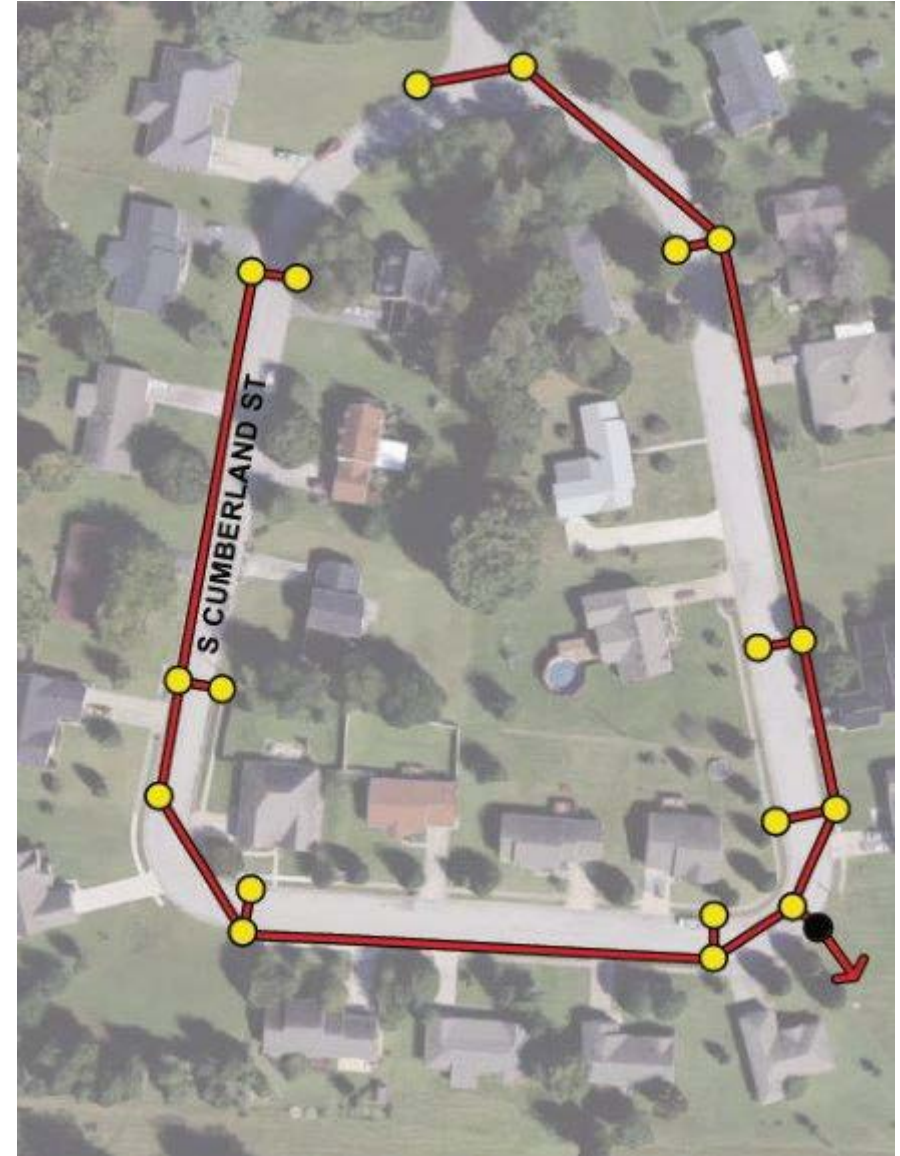
# Cost Savings

- Conventional storm sewer (shown at right):
  - 10-yr design storm
  - 1,915 lf 15" – 30" pipe
  - 18 CBIs, 1 MH
- Increased cost of nearly \$100,000, or 42% of total project

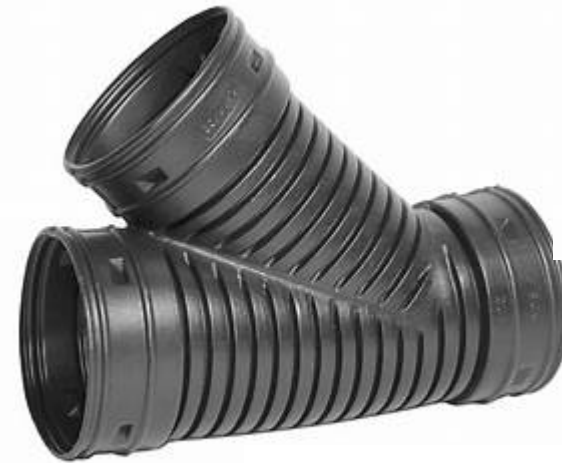
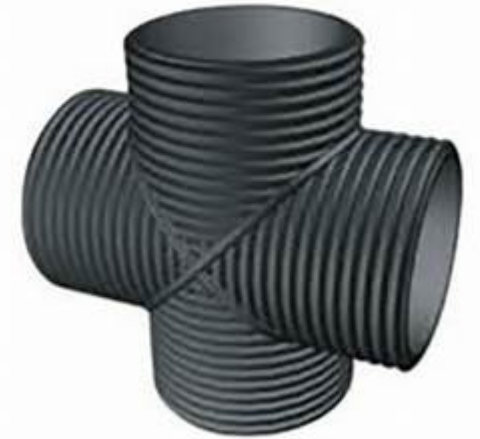
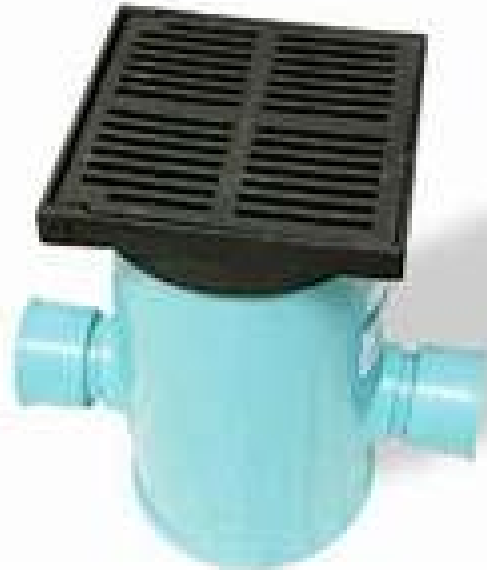
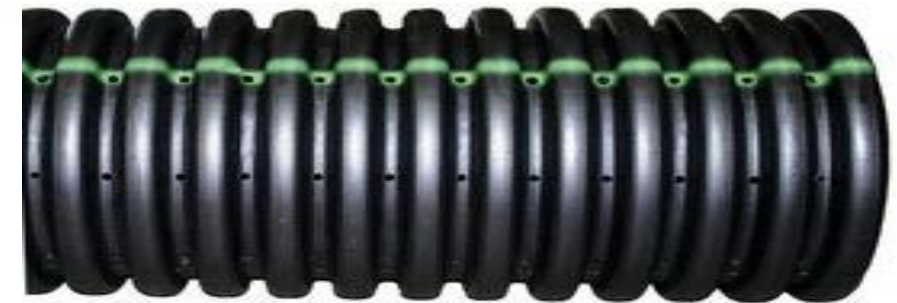
# Materials

- Perforated HDPE Corrugated Pipe
- Fittings – Wyes and Cross
- Nyloplast Drain Basins
- Curb Inlets

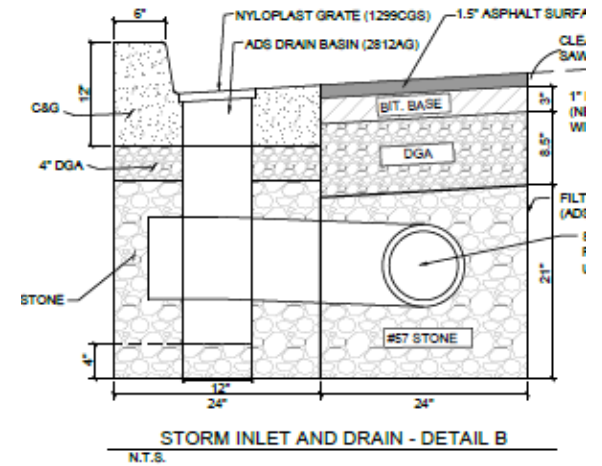
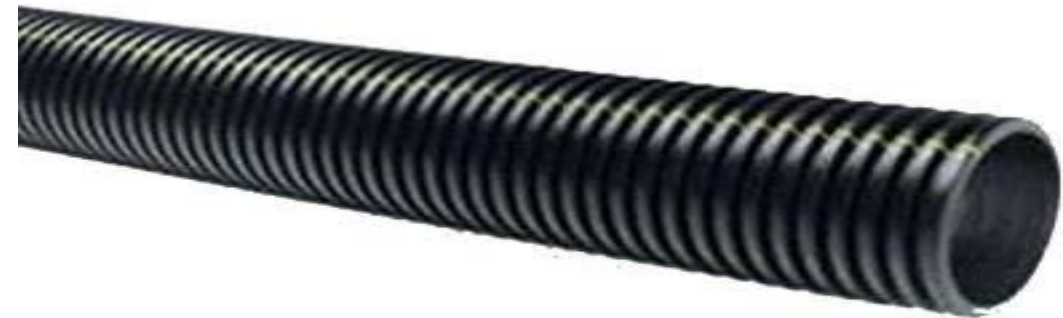
# Perforated HDPE

- Dual wall for improved conveyance and strength
- Perforated for capture and conveyance
- Flexible enough to build radius into design
- Gasketed connections at structures for long service life

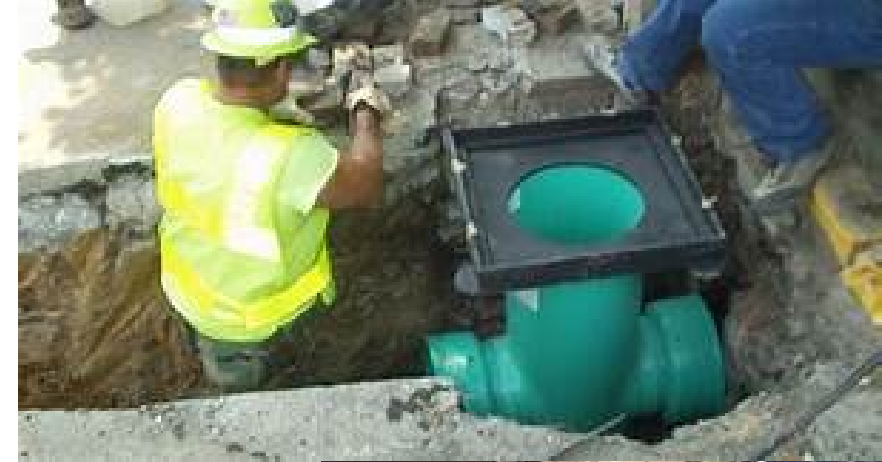
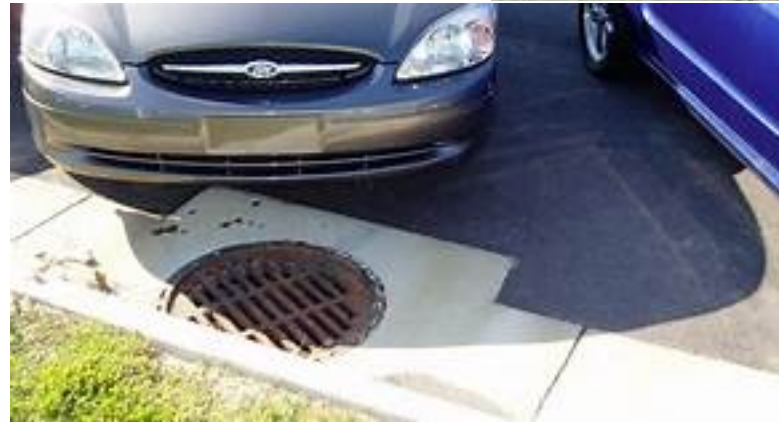
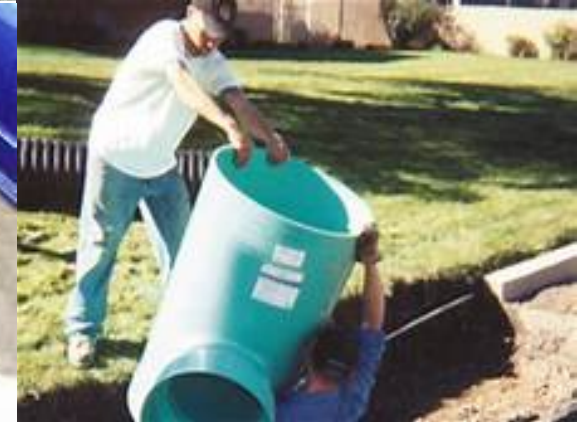
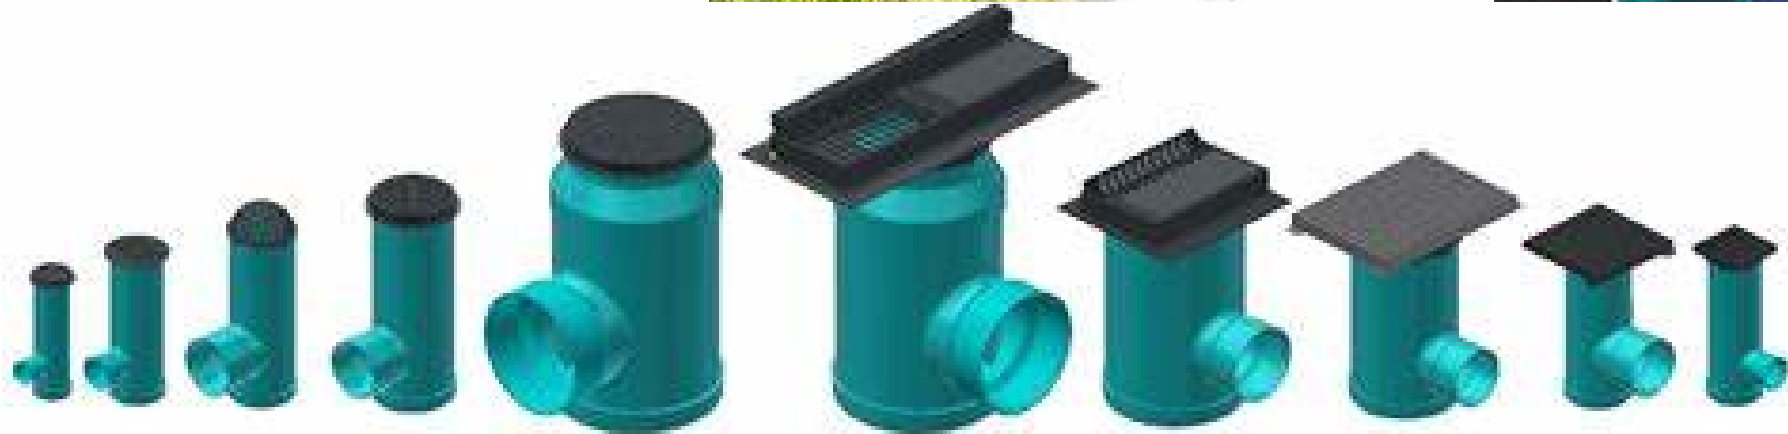
# Nyloplast Basins and Grates

- Lightweight and Easy to Install
- Flexible...many options
- Traffic Rated
- Watertight Connections

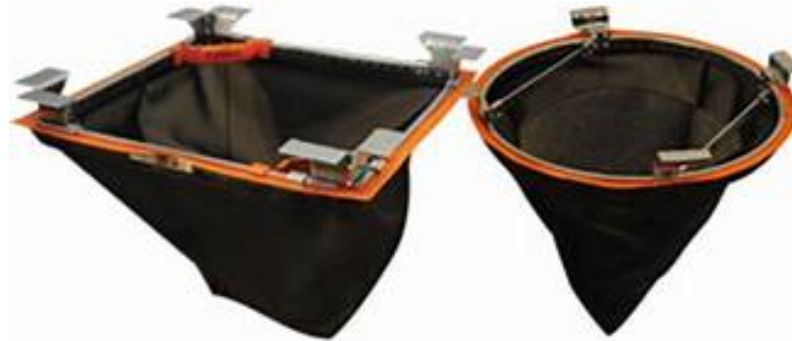
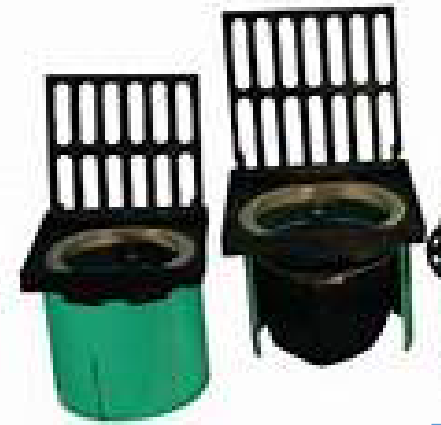
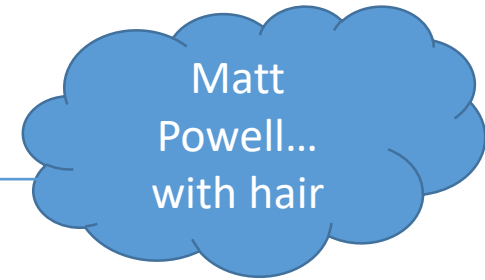
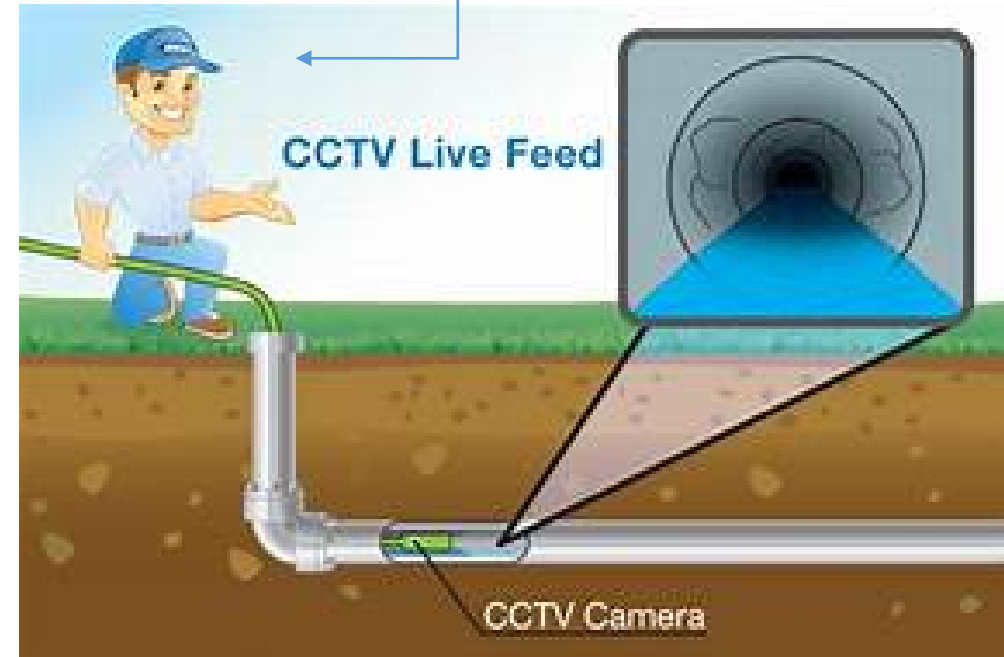
# Maintenance

- Grate Cleaning
- Removable Grates
- May be Able to CCTV
- Smooth Wall Pipe Flushes Easily

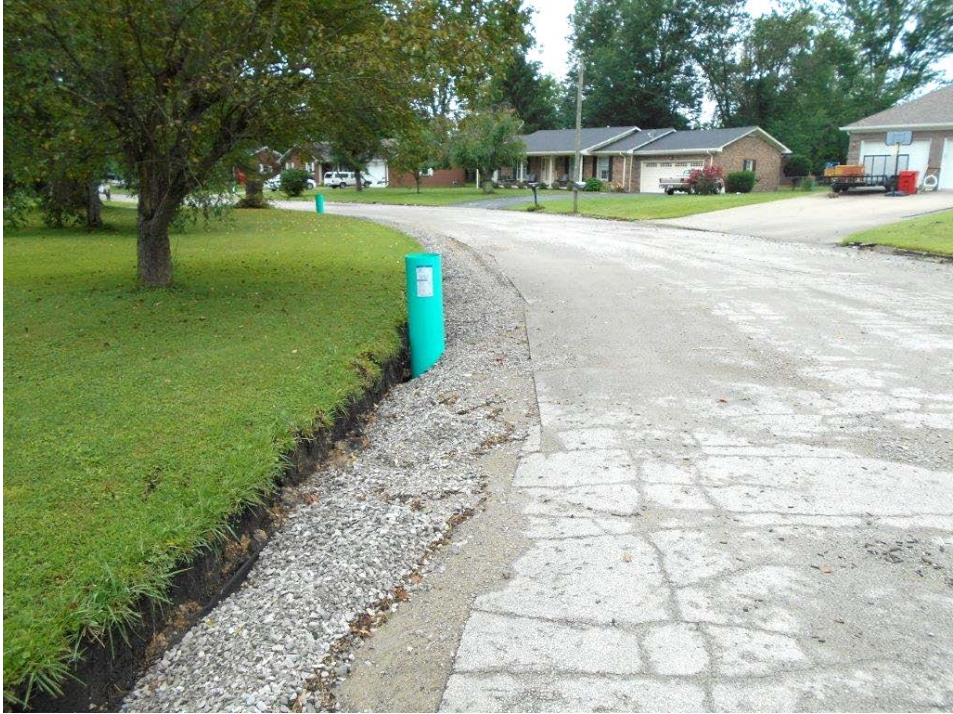
Detail "A" – replace curb & gutter

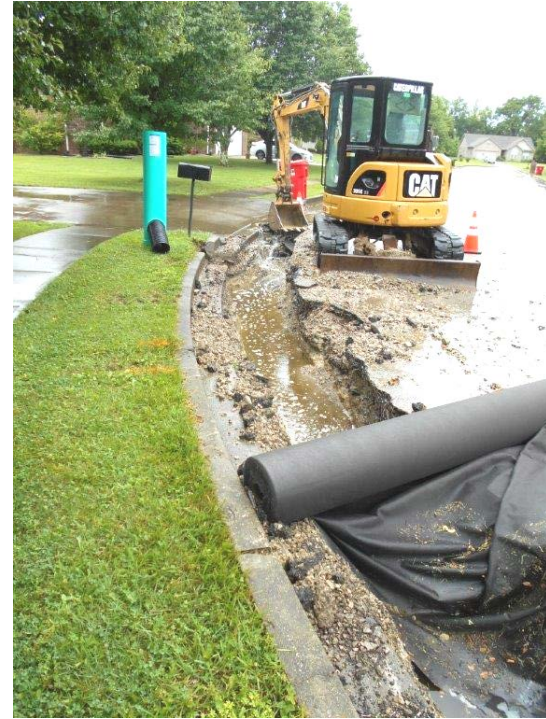
Detail "B" at downstream end

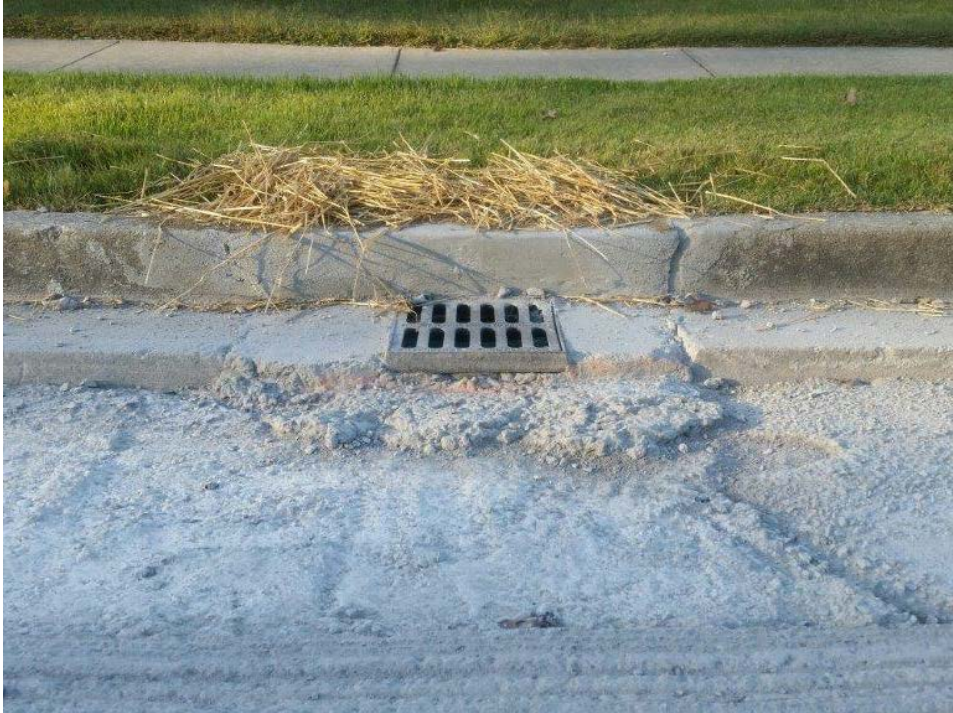
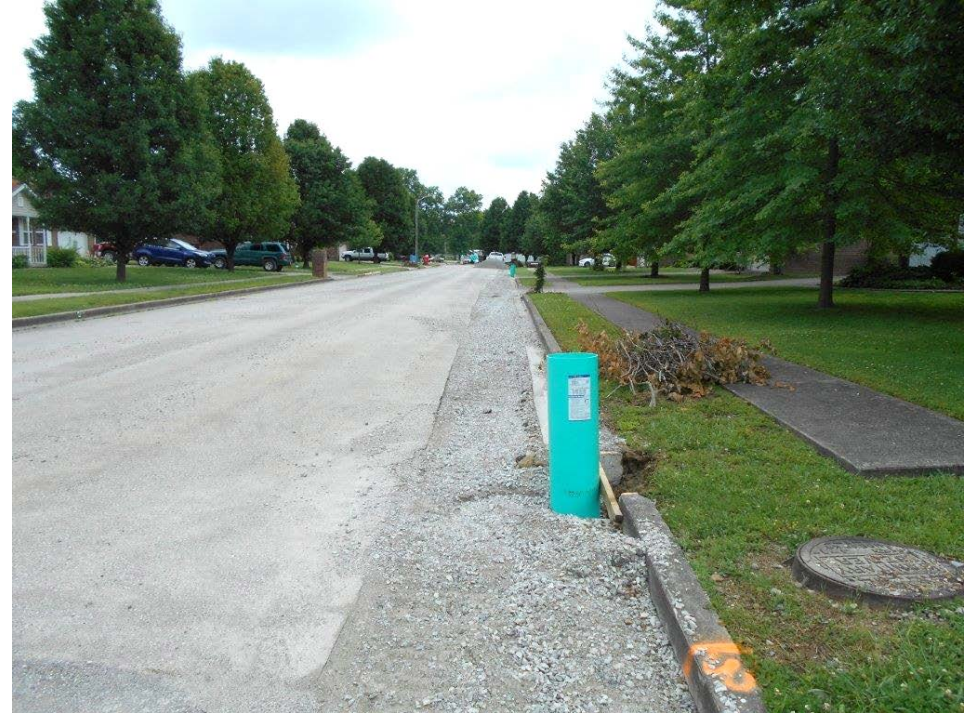
Detail "B" – salvage existing curb & gutter

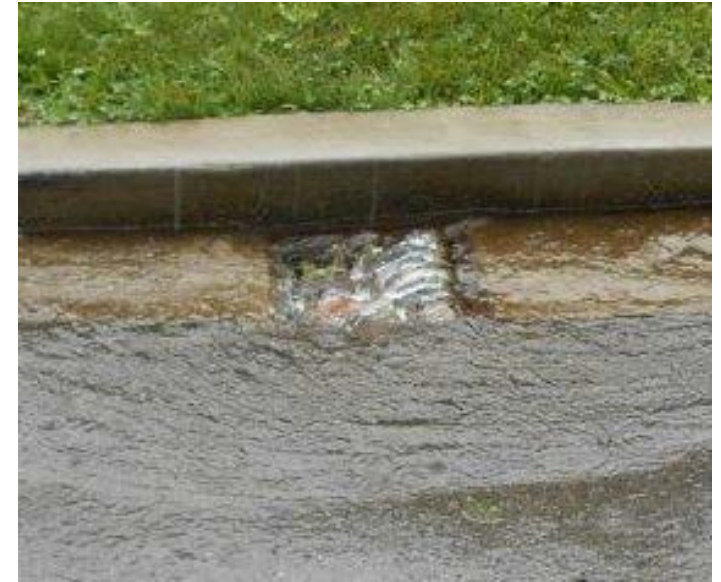
Upstream inlet

- Construction completed mid-2017
- Residents pleased with surface drainage
- Minimal leaf-clearing by residents
- No maintenance by City so far
- Pavement durability – TBD?
