Using Stream Restoration to Enhance a CSO Control Project

Chris Rust, P.E. – Strand Associates, Inc.

Quebec Heights Stream Restoration Site

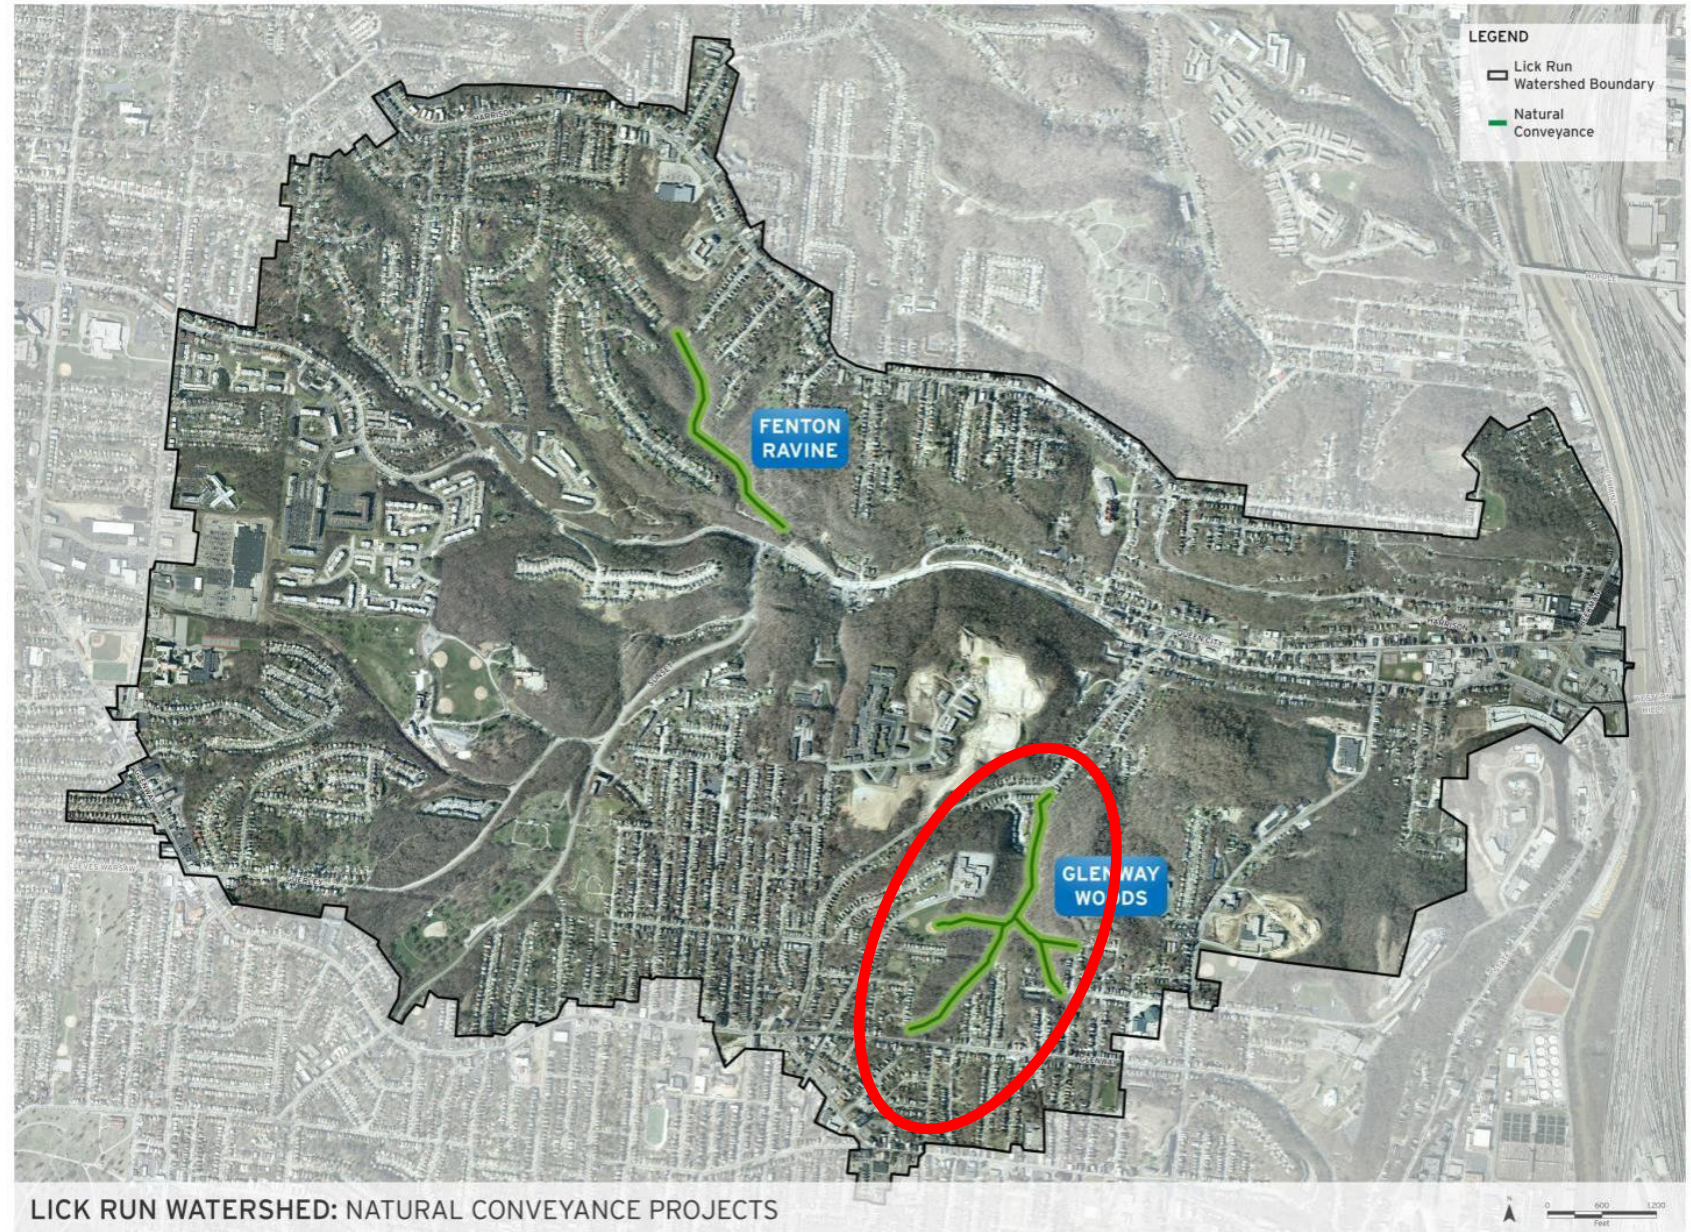
- One of two strategic sewer separation projects utilizing a naturalized open channel within the Lick Run Watershed.

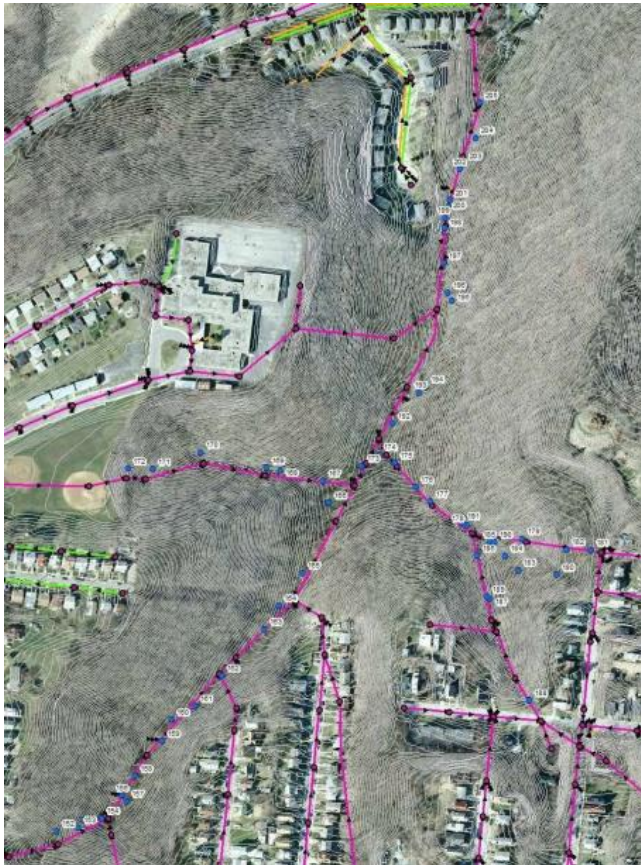
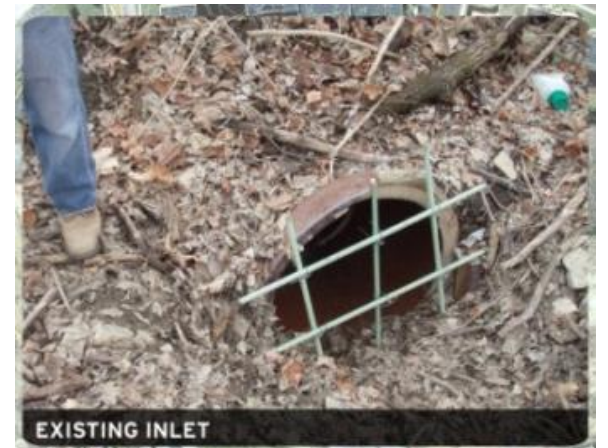
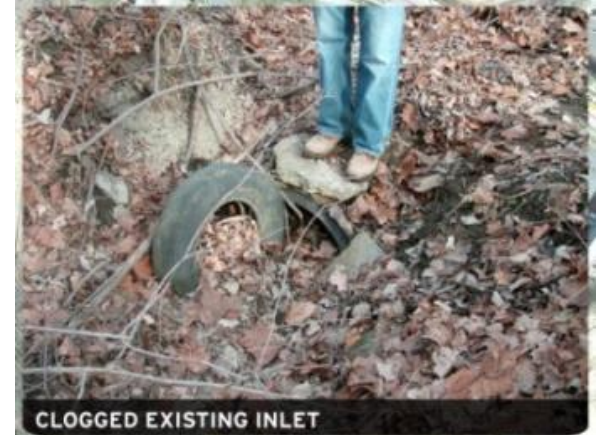
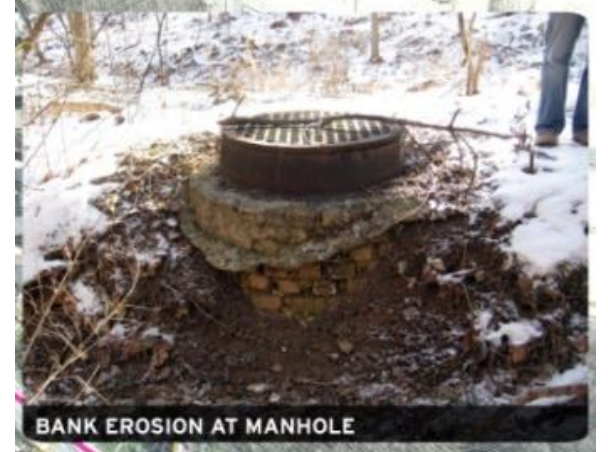
- Combined sewer located in the channel area conveys flow from surrounding neighborhoods.
- Stormwater from the stream channel allowed to enter the combined sewer through various inter-connections.
- Existing erosion/hydromodification issues in the channel.

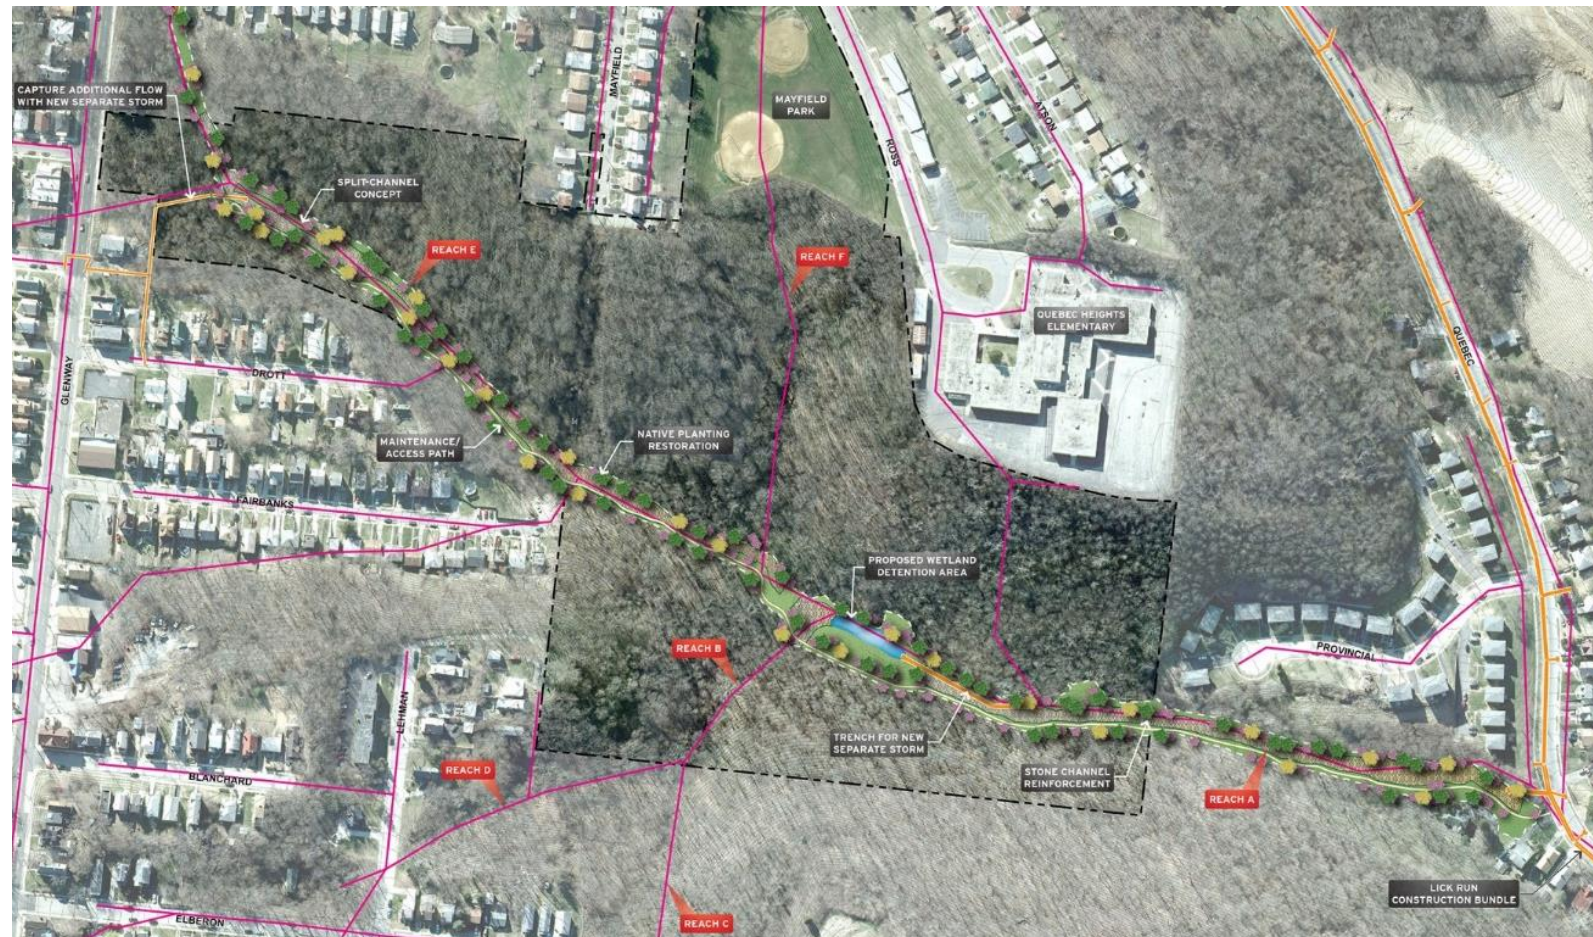
- Open channel conveyance - stabilize and enhance 5,500 linear feet.
- Approx. 1,300 linear feet of separate storm sewer ranging from 12 inches to 15 inches.
- Capturing stormwater runoff from 82 acres - 49 million gallons of runoff volume per year.
- Remove this flow from the combined sewer, and reduce CSOs.

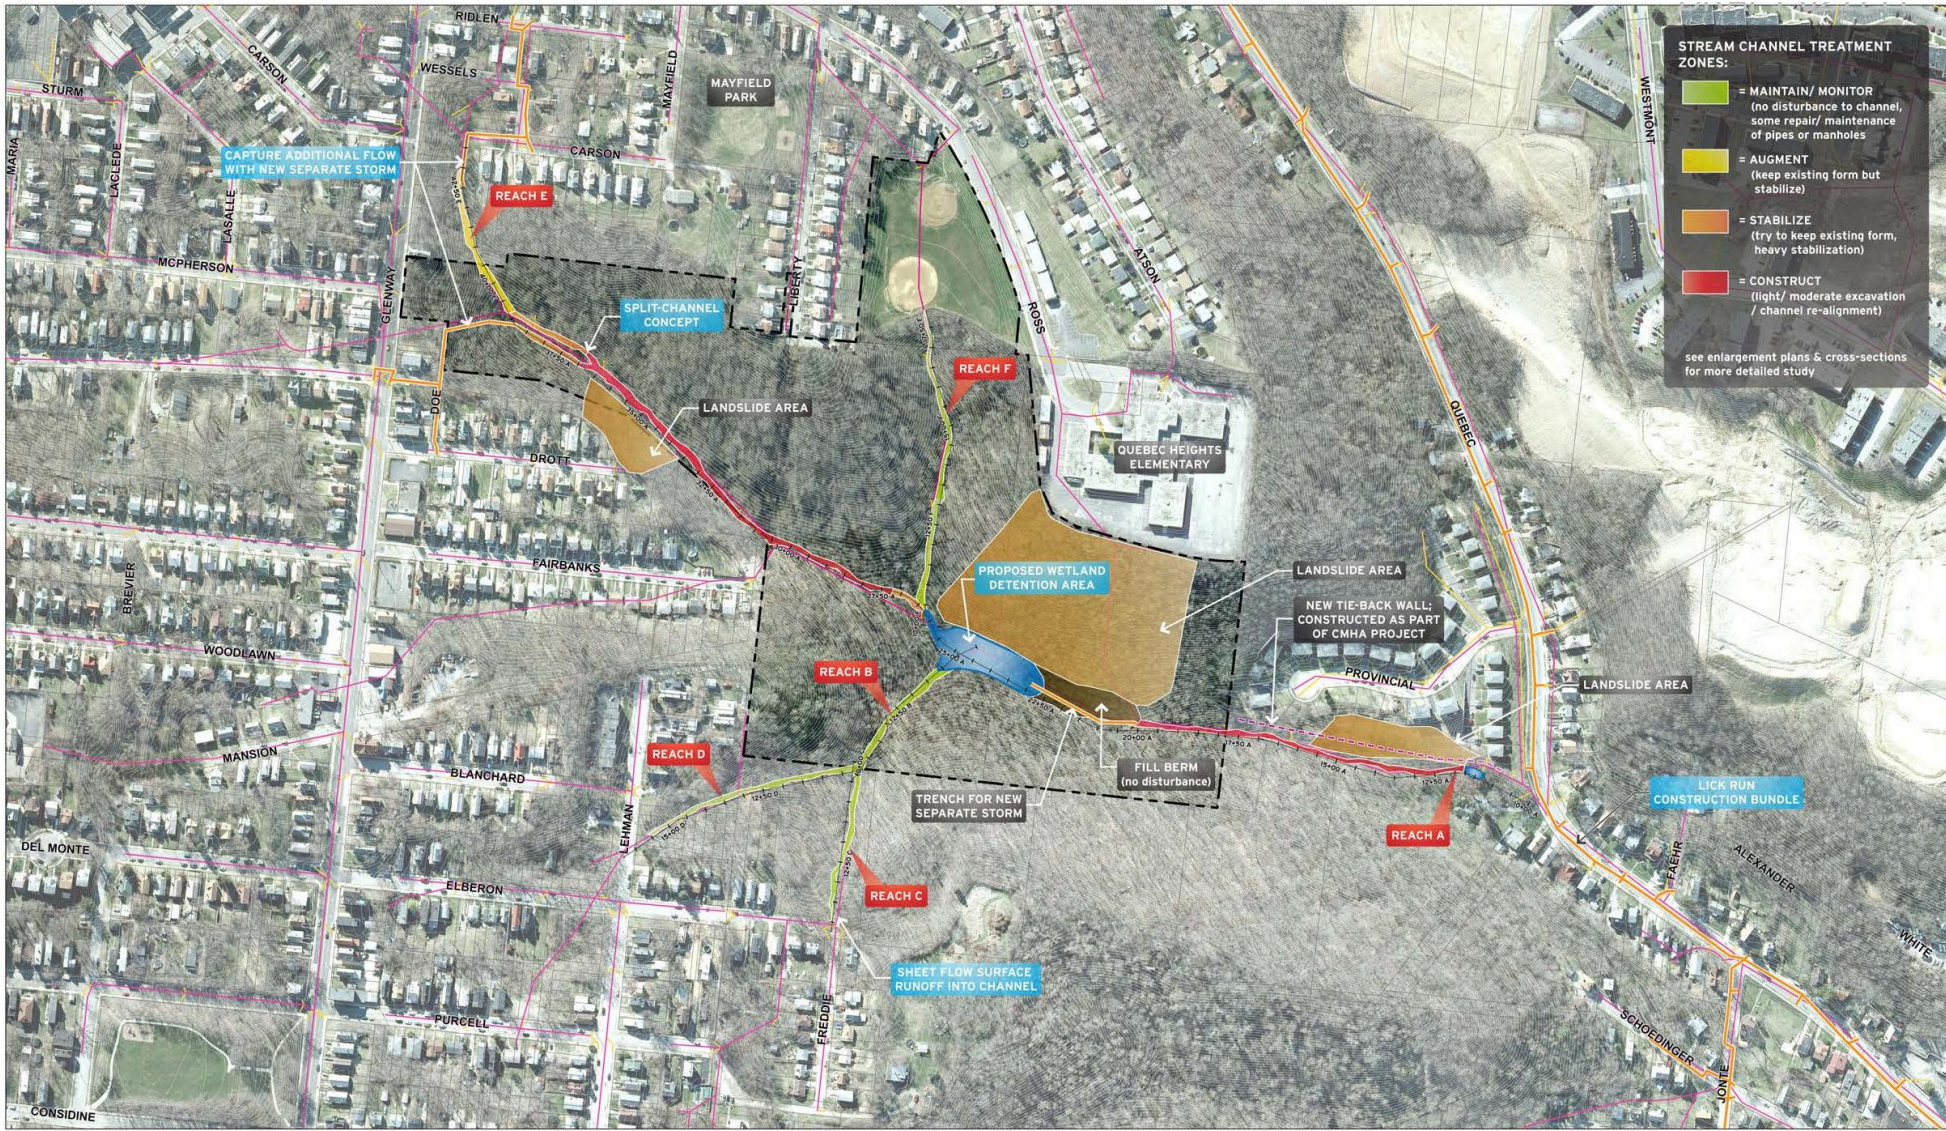
*** GLENWAY WOODS CONCEPT PLAN:
TREATMENT ZONES**

STREAM CHANNEL TREATMENT ZONES:

- = MAINTAIN/ MONITOR
(no disturbance to channel, some repair/ maintenance of pipes or manholes)
- = AUGMENT
(keep existing form but stabilize)
- = STABILIZE
(try to keep existing form, heavy stabilization)
- = CONSTRUCT
(light/ moderate excavation / channel re-alignment)

see enlargement plans & cross-sections for more detailed study

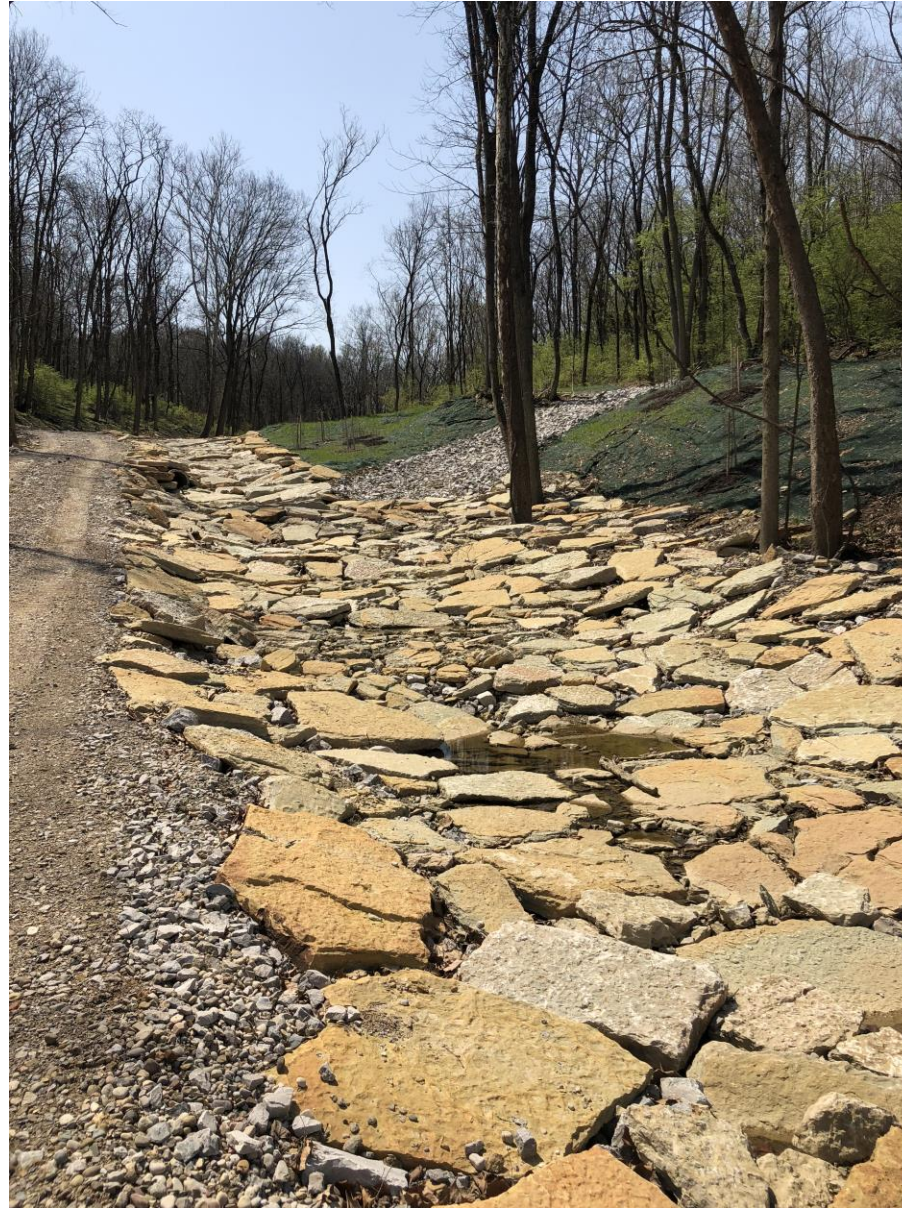
- Improve water quality by passing runoff through a series of stormwater best management practices.
- Preserve and enhance habitat/ecology by designing around high quality trees.

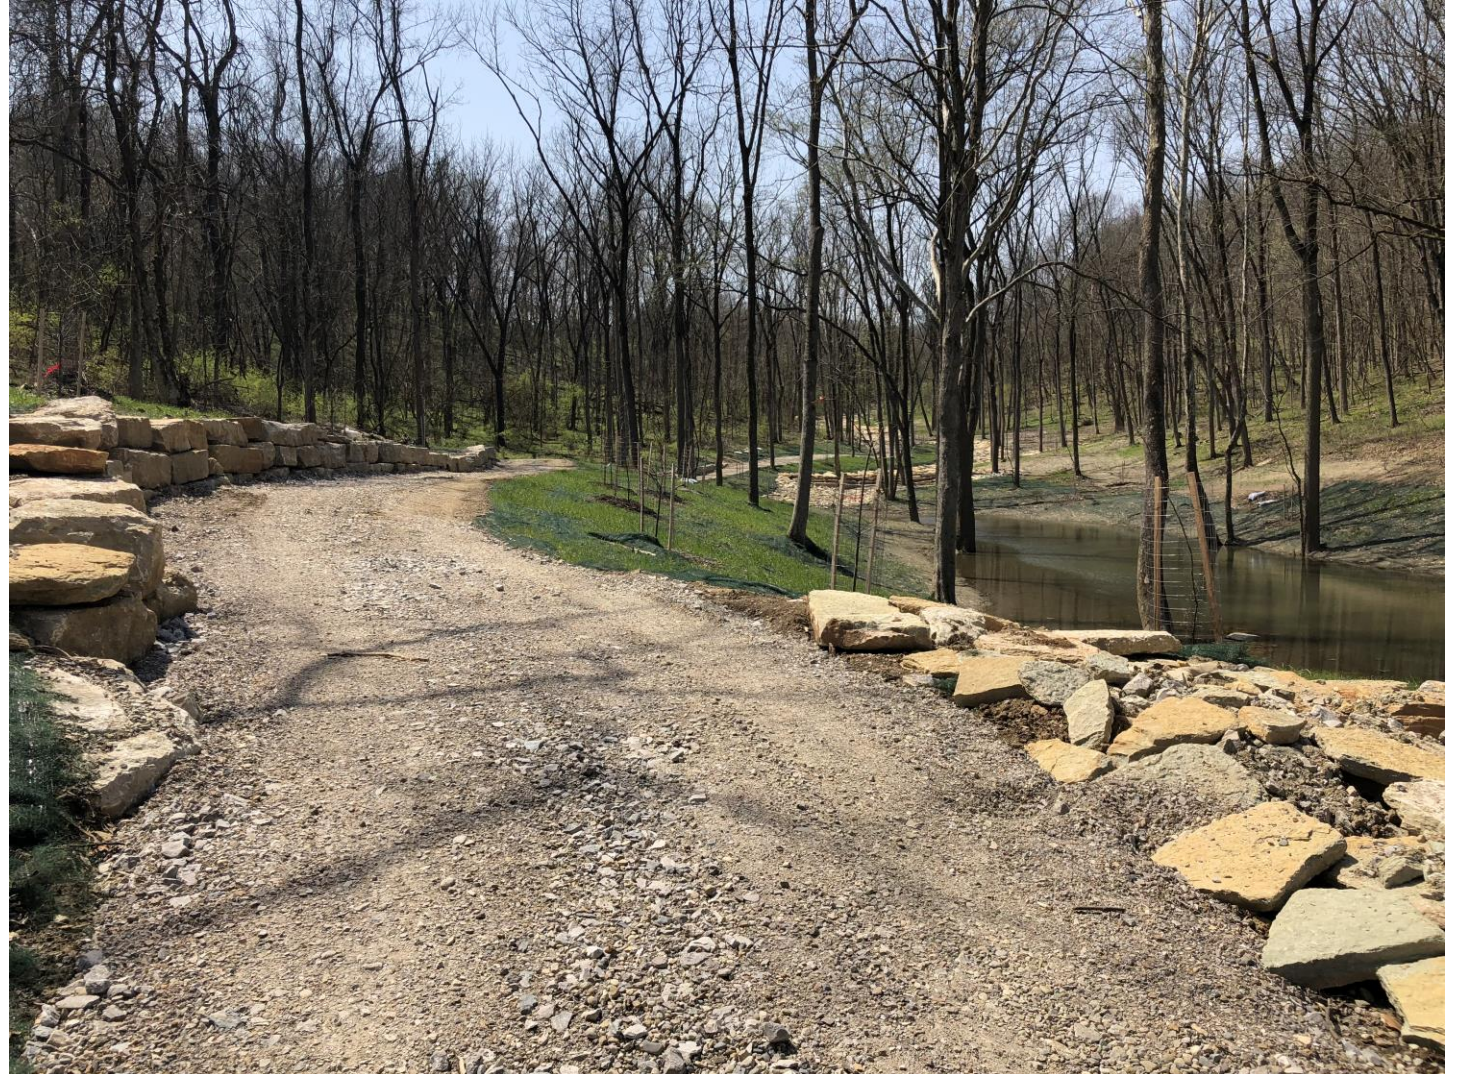
- Use surface features to provide water quantity benefit
- Convey the 25-year event in the channel
- Safely pass the 100-year event in the valley

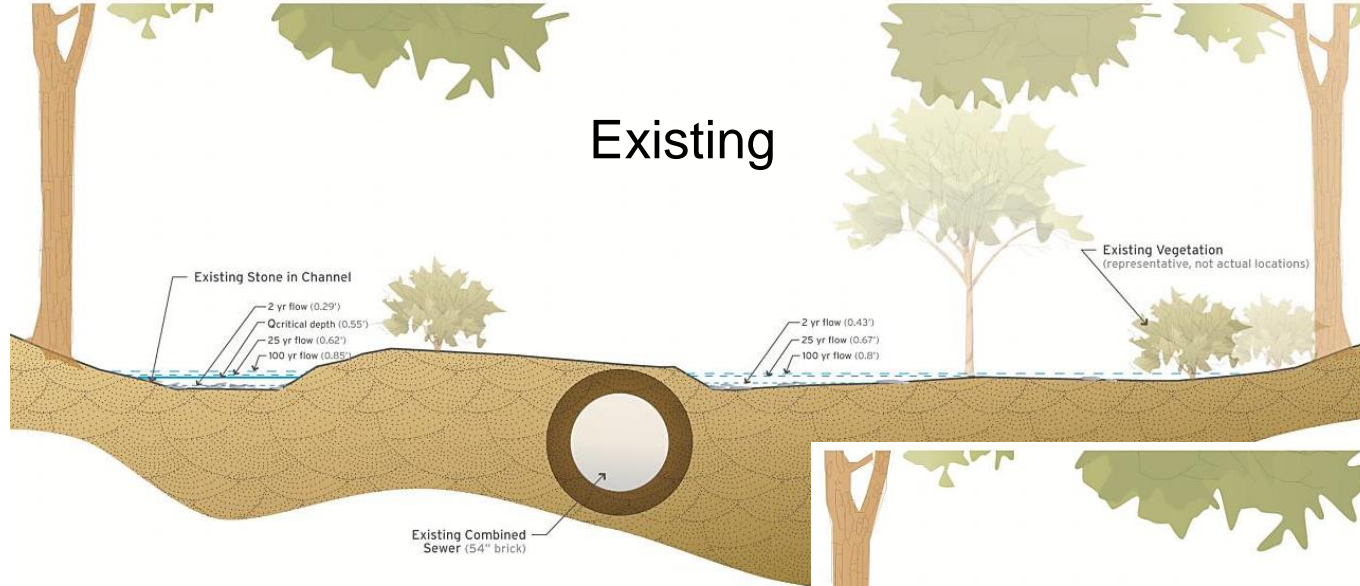
Reach A: Cross-Section (37+75)
Glenway Woods
Existing Conditions
(looking downstream) 1/4" = 1'-0"

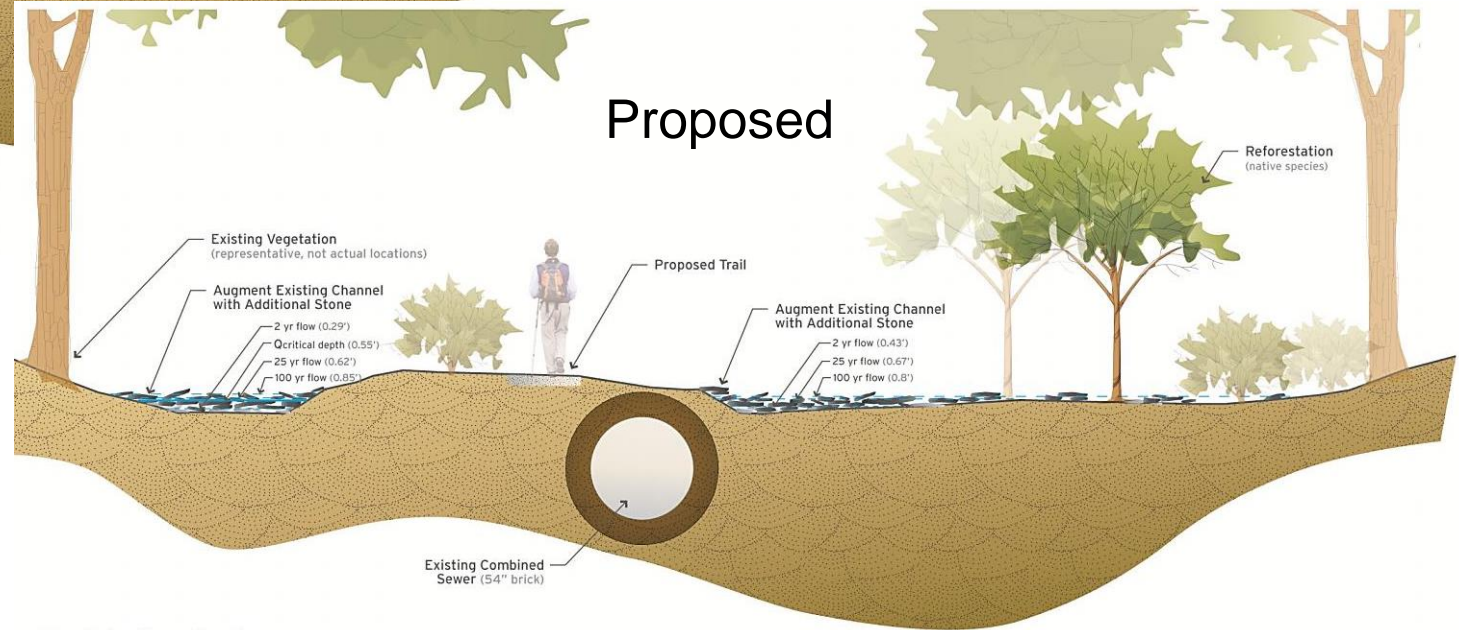
Reach A: Cross-Section (37+75)
Glenway Woods
Proposed Treatment: STABILIZE
1/4" = 1'-0"
(looking downstream)

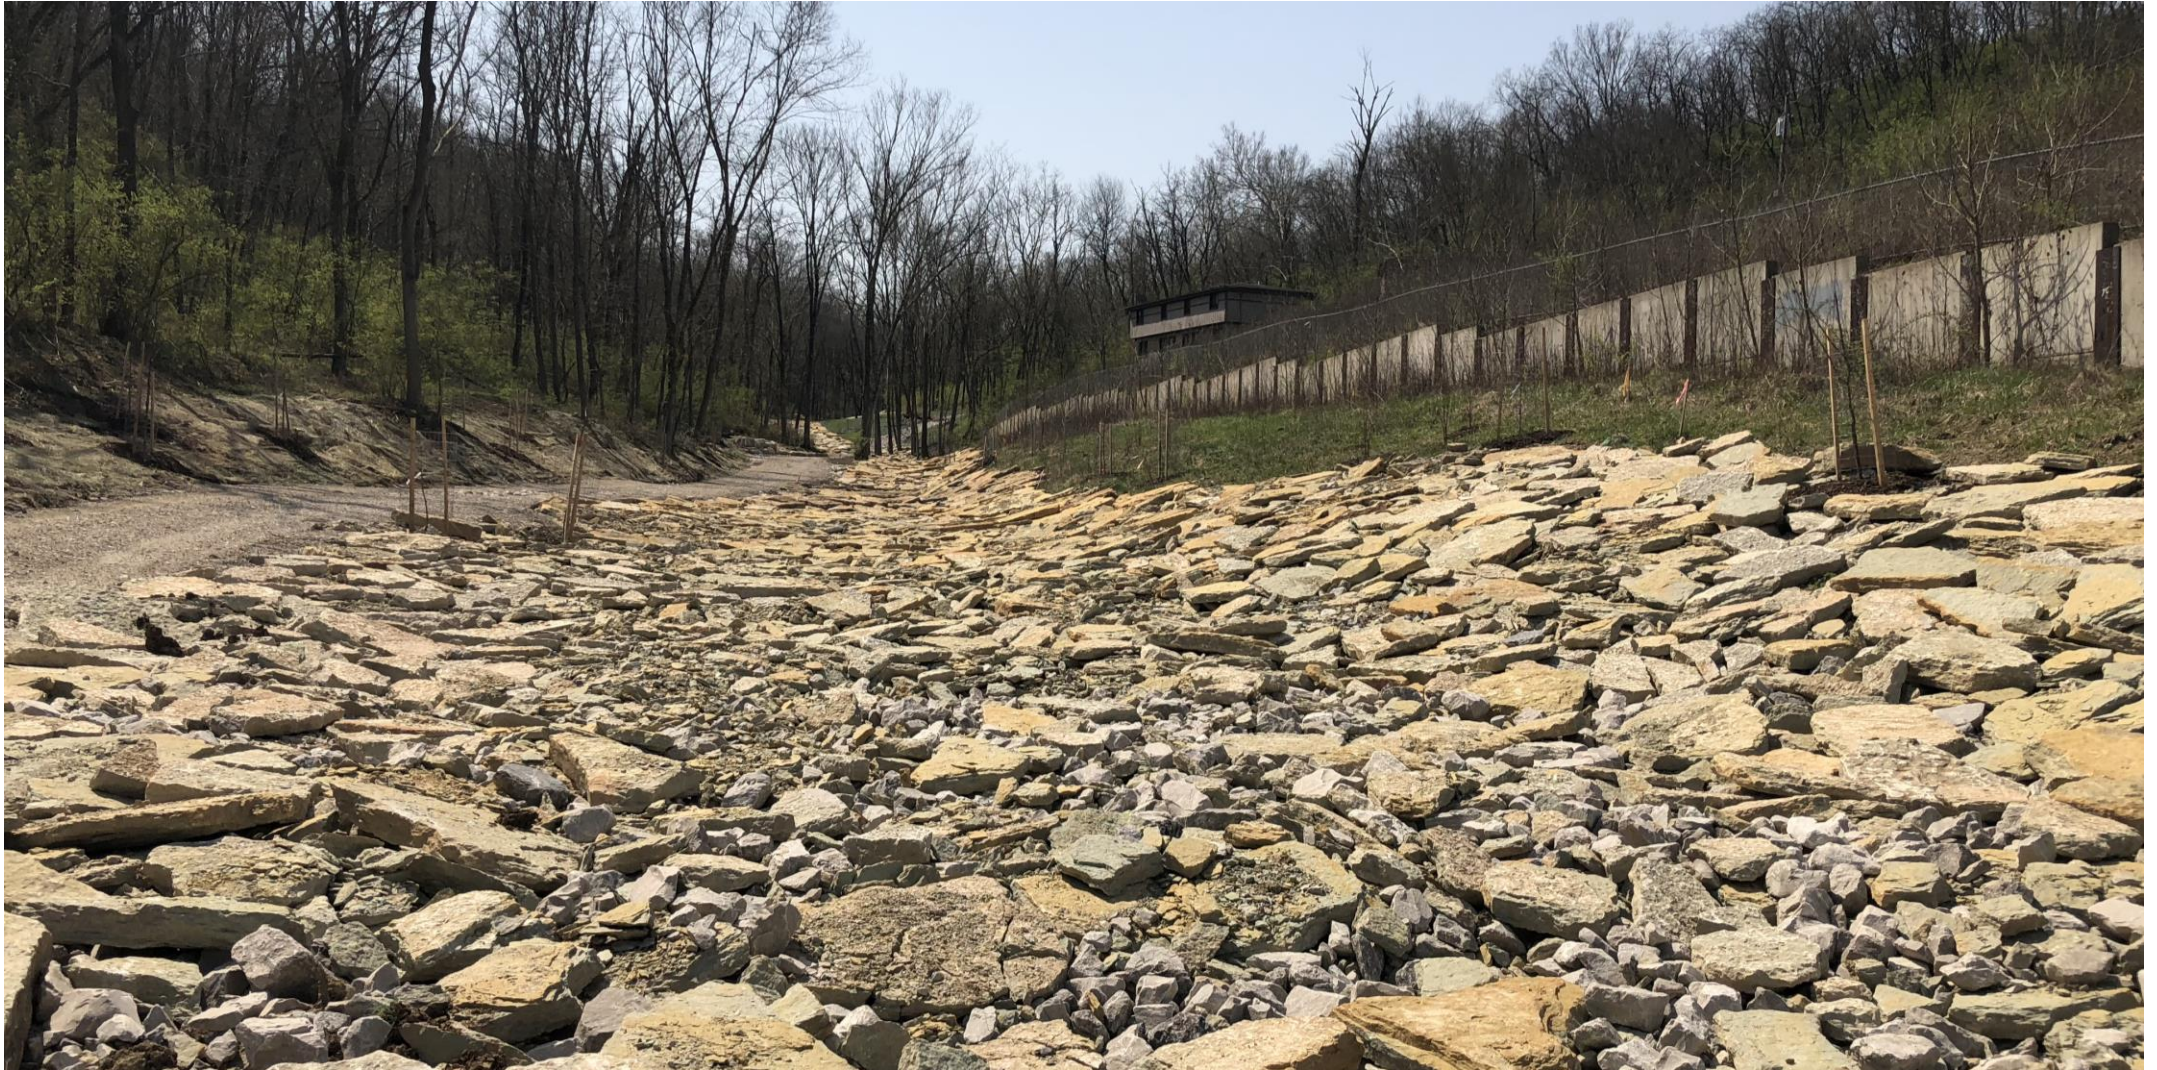
Flat and Wide Reaches

- Medium creek rock mixed with rip rap to create natural habitat, allow for gradual infiltration and promote the development of self-forming pools and riffles

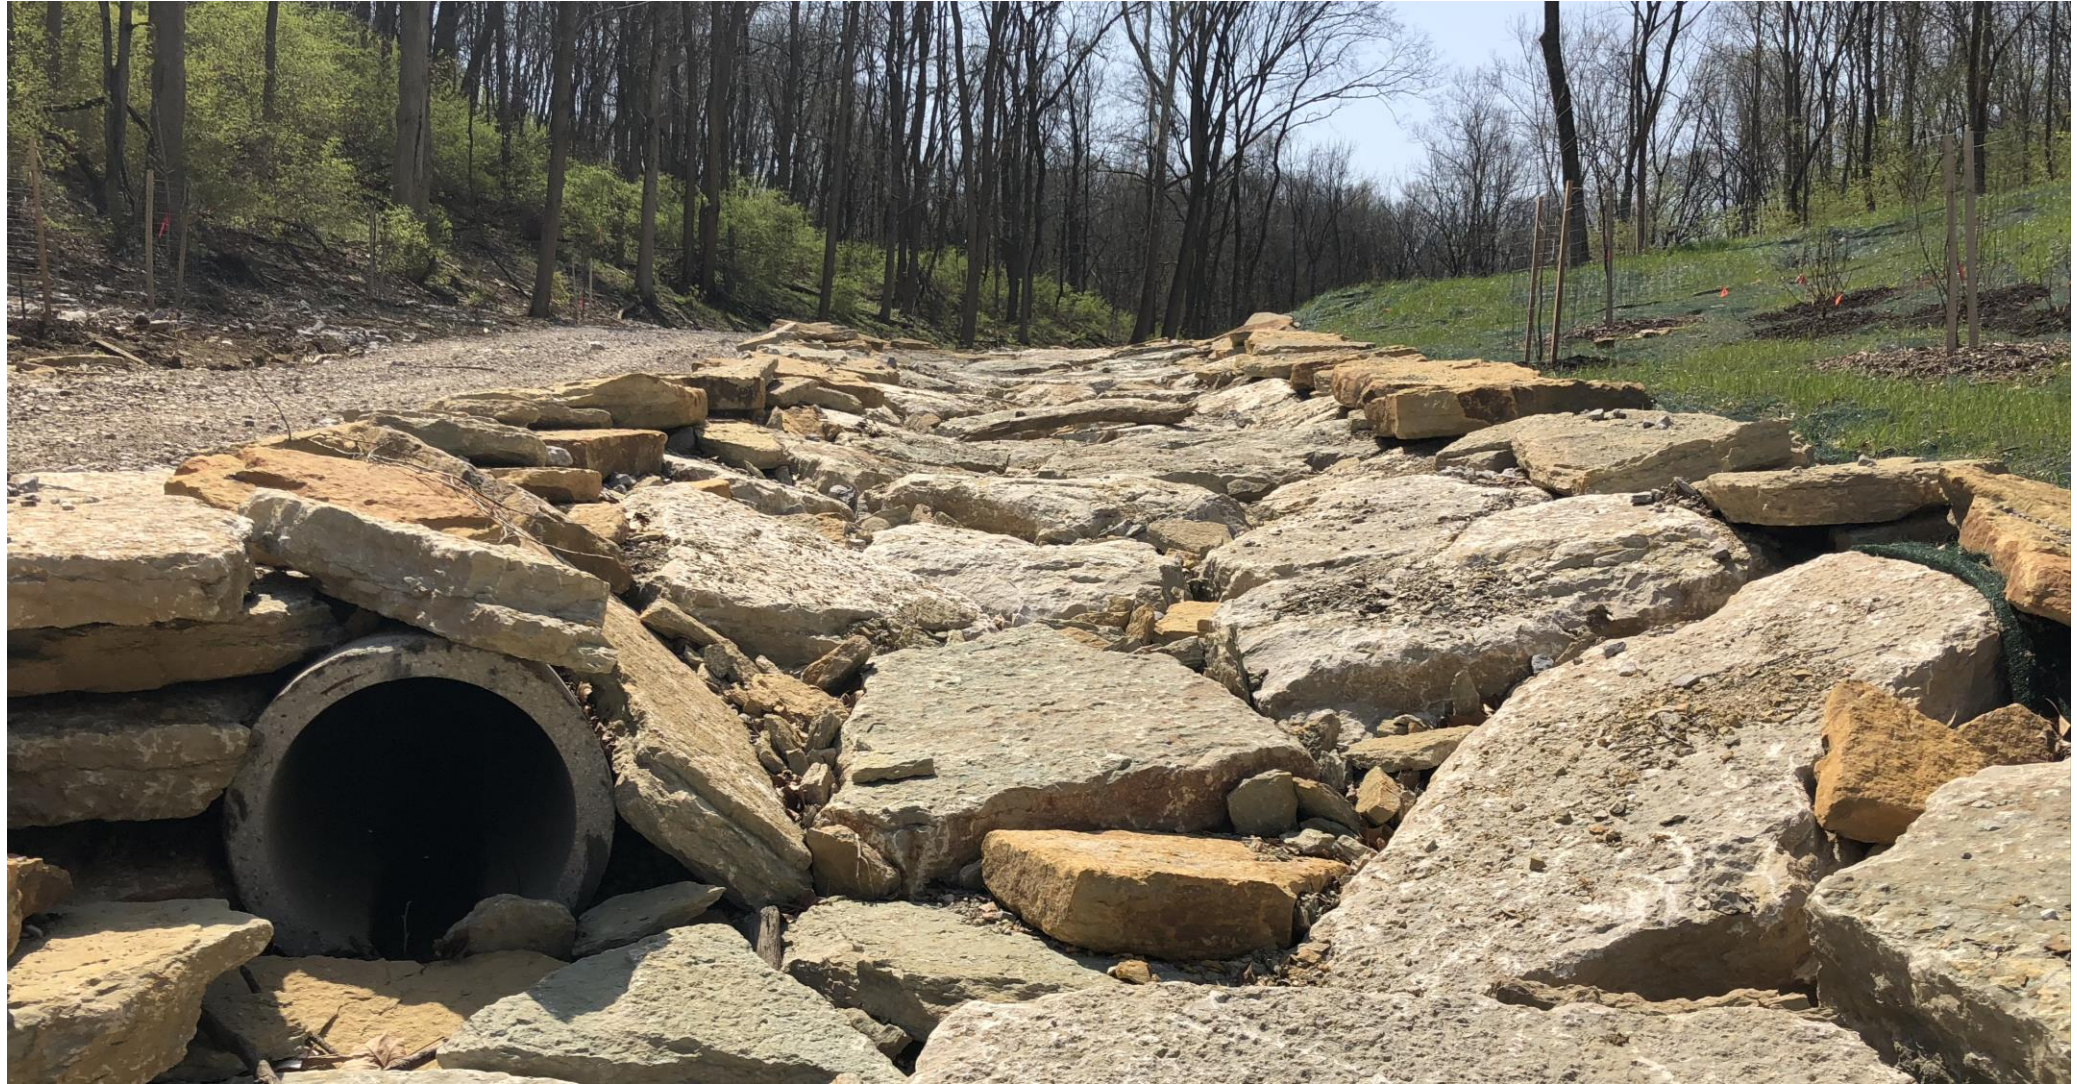
Steep and Narrow Reaches

- Ledge rock cascade to maintain stability and prevent erosion

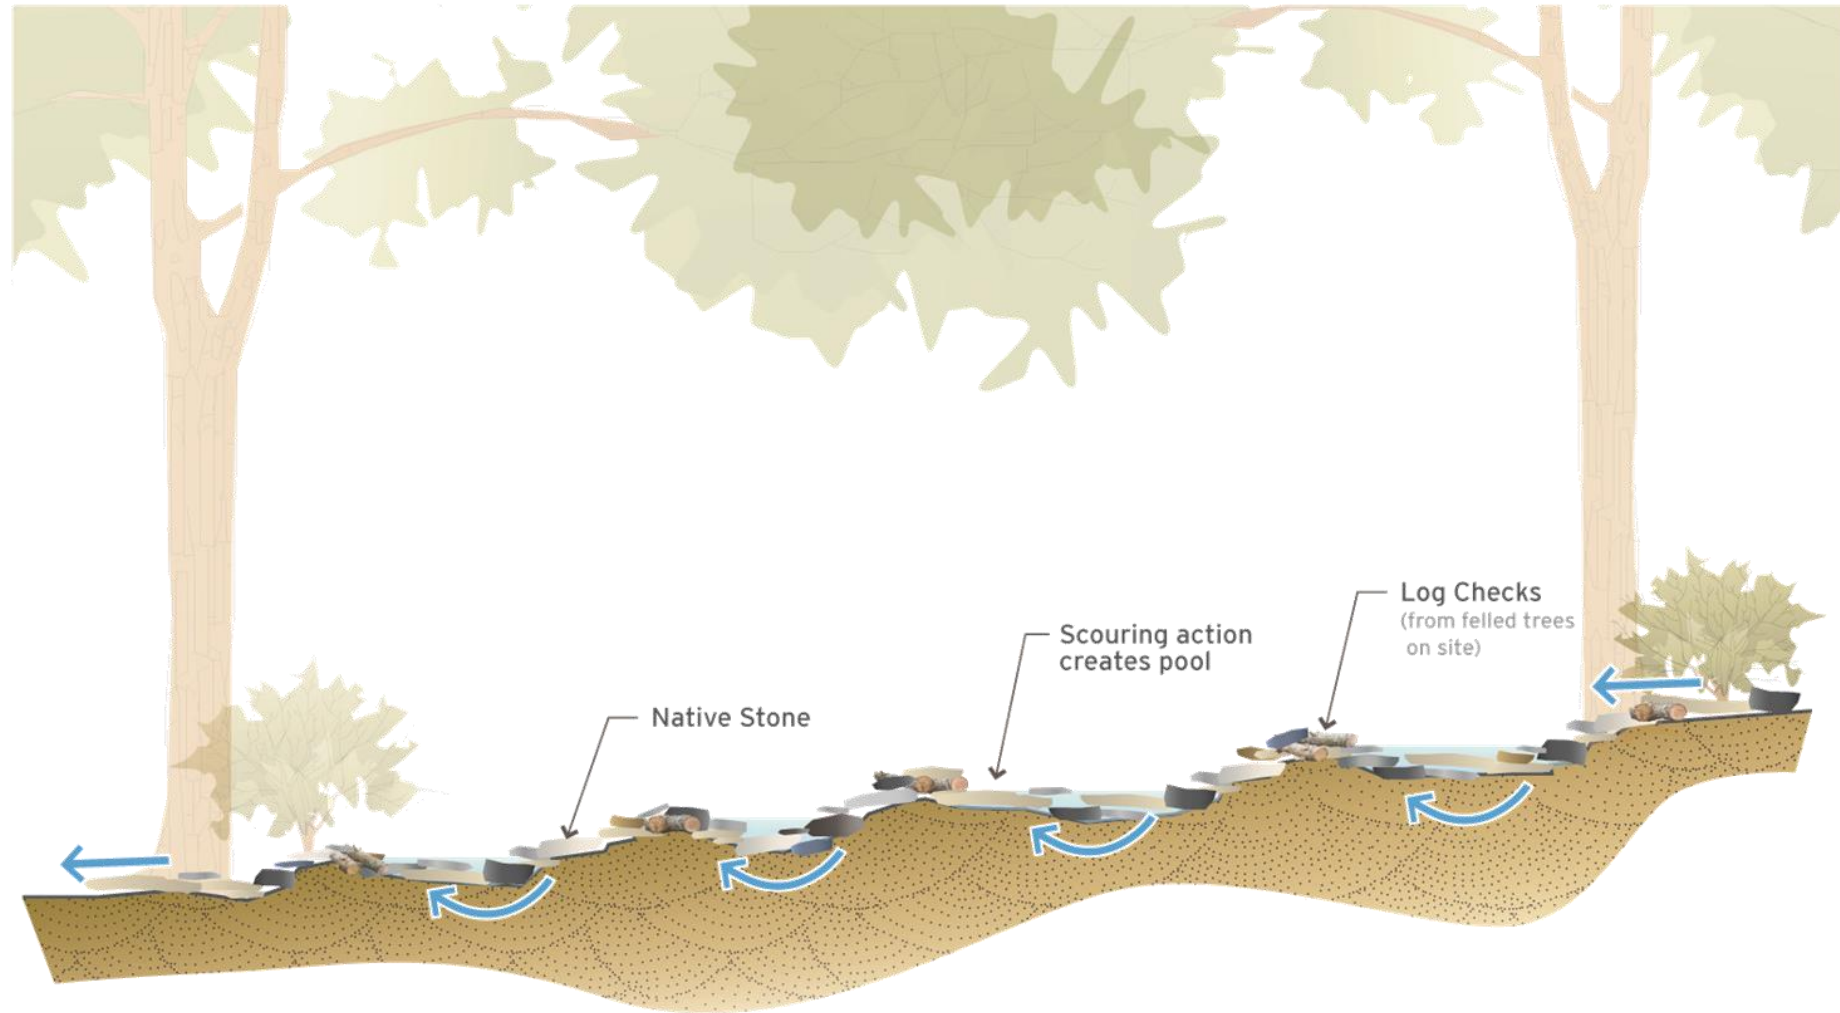
Step Pools Concept

- Step pools provide energy dissipation and habitat in steeper reaches

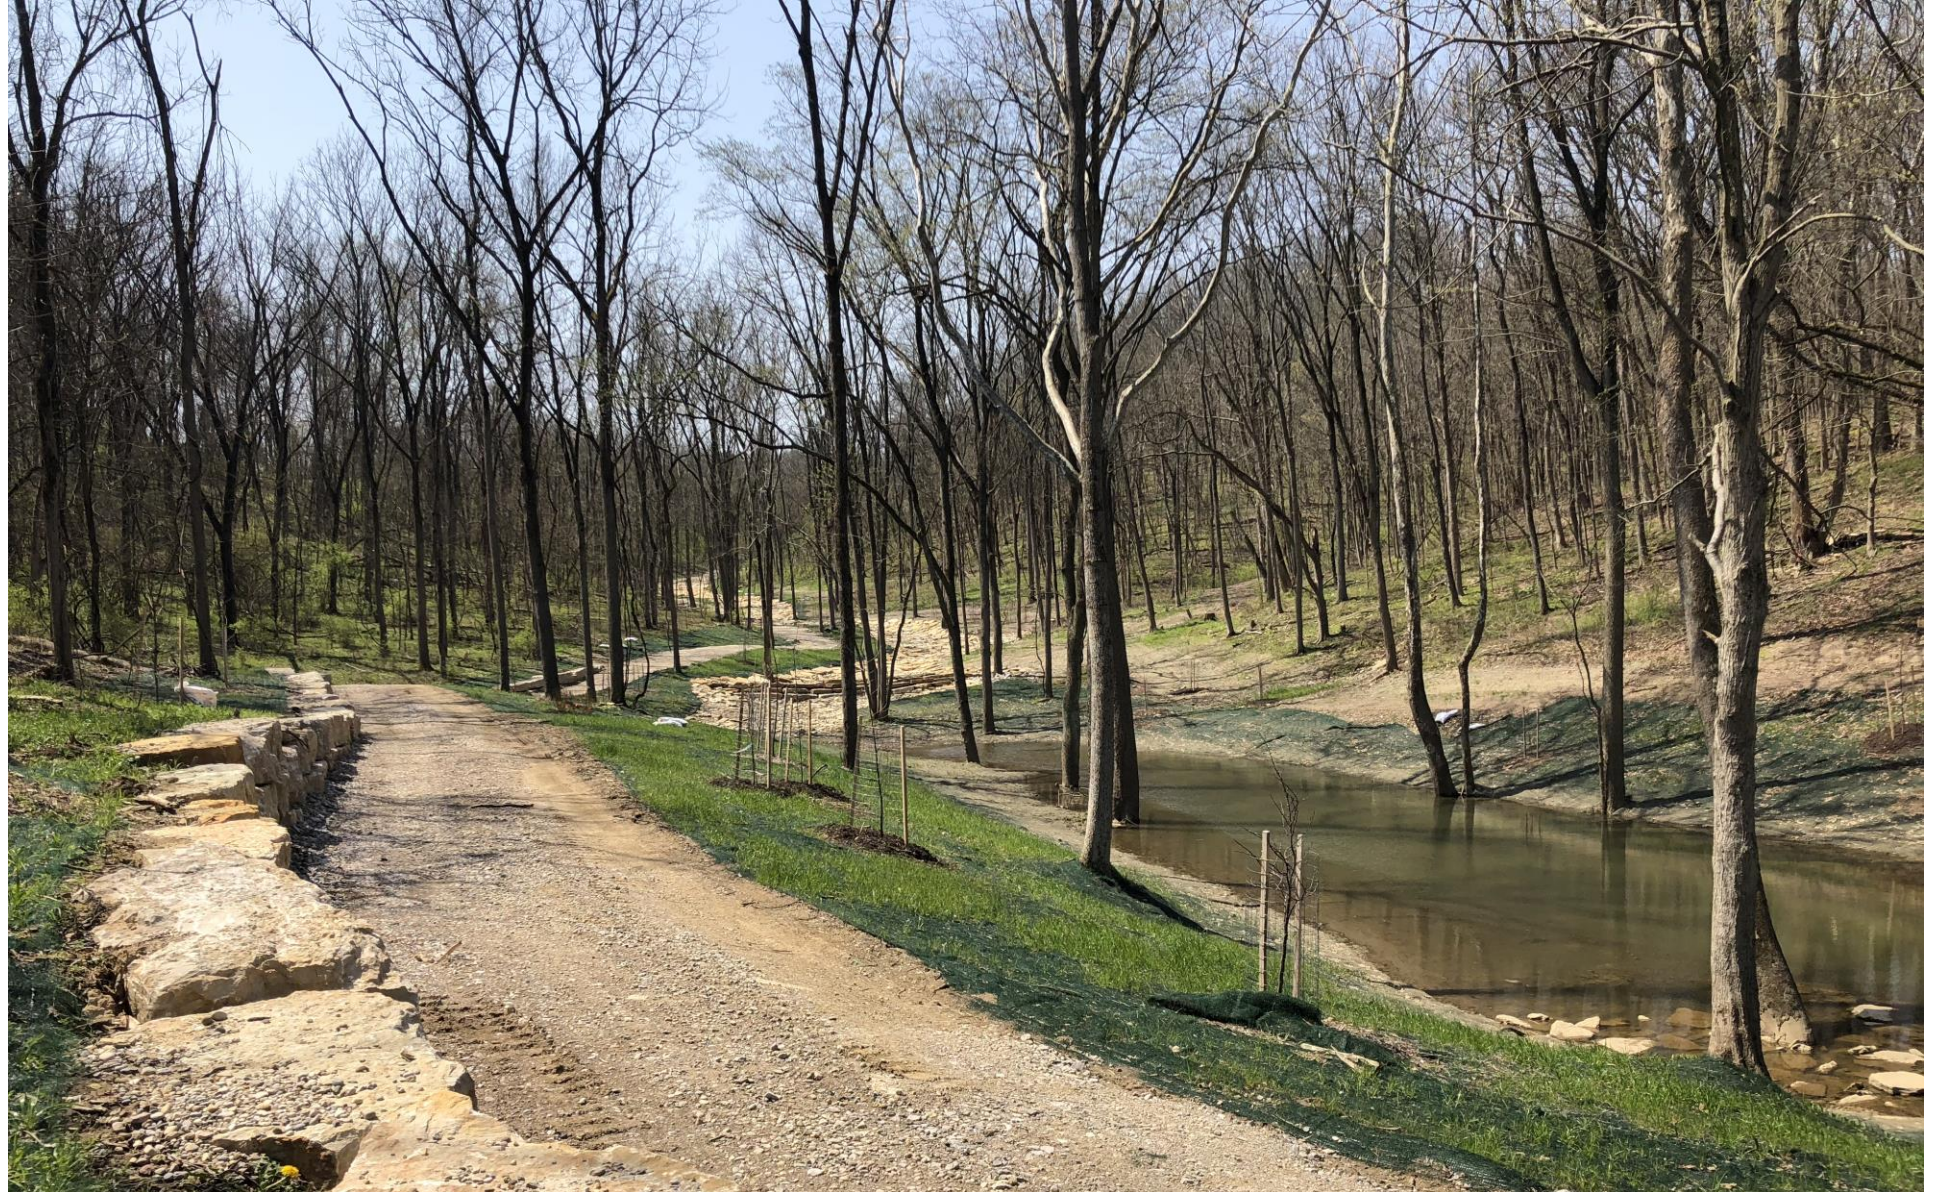
Wetland Detention

- Designed for the 10 and 25-year design storms

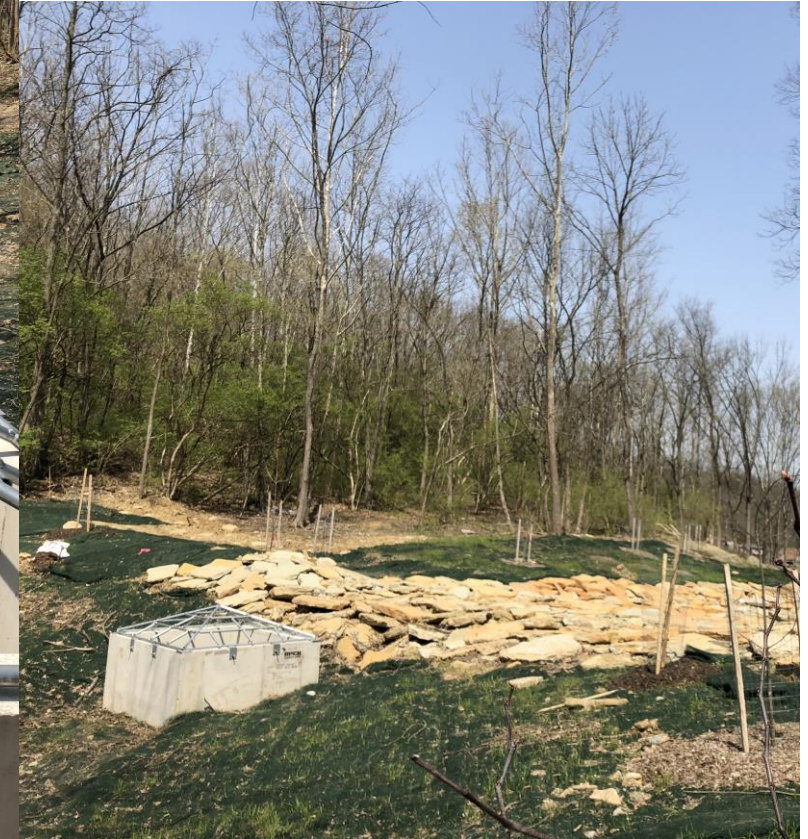
Detention Pond
Spillway

- As constructed, the overflow spillway did not conform to the design to control the 10-year and 25-year design storms
- Two modification alternatives were presented to MSDGC to meet design intent with minimal additional work.
- MSDGC decided on modifying the spillway according to alternative #2
