Using Stream Restoration to Enhance a CSO Control Project

Chris Rust, P.E. – Strand Associates, Inc.

Quebec Heights Stream Restoration Site

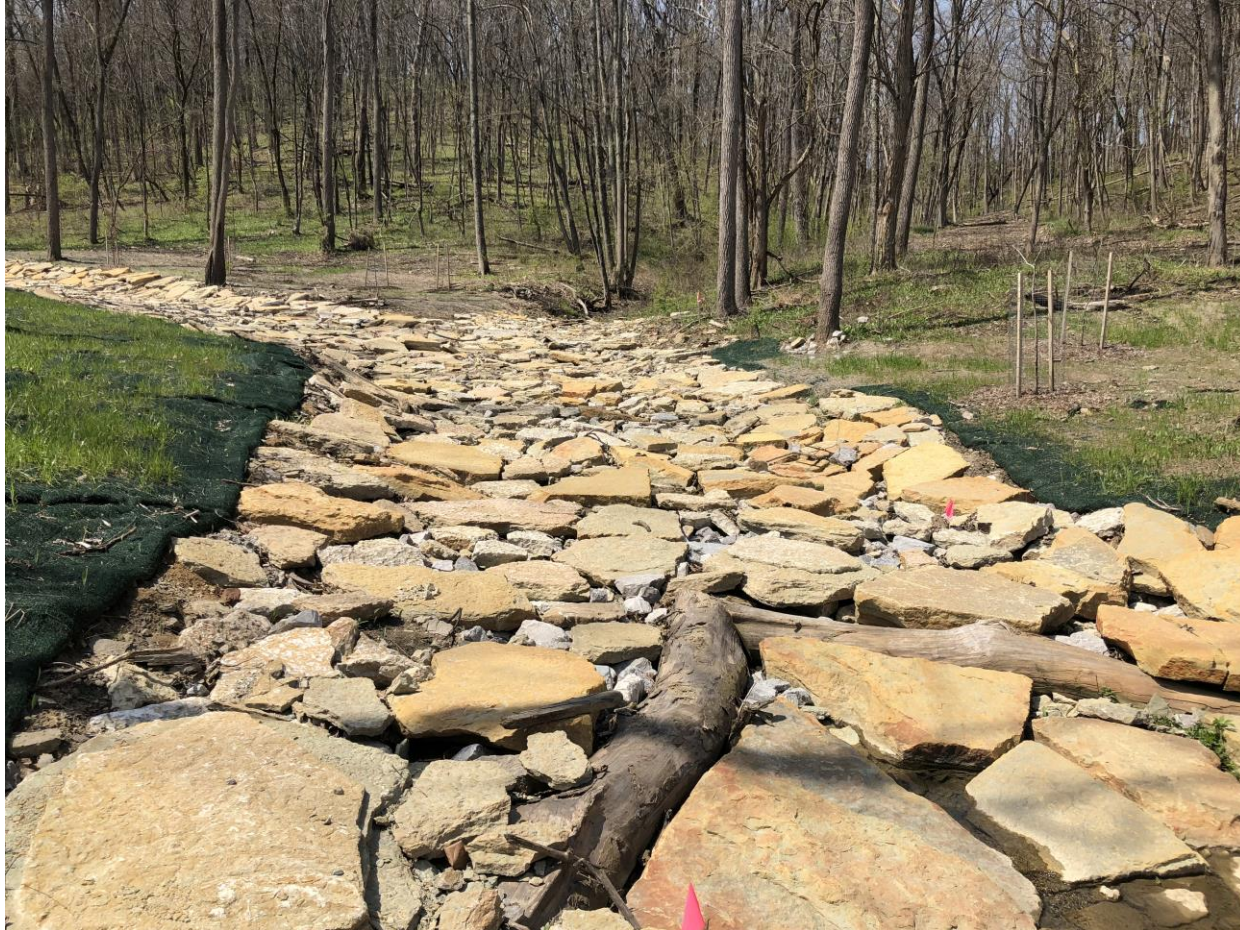
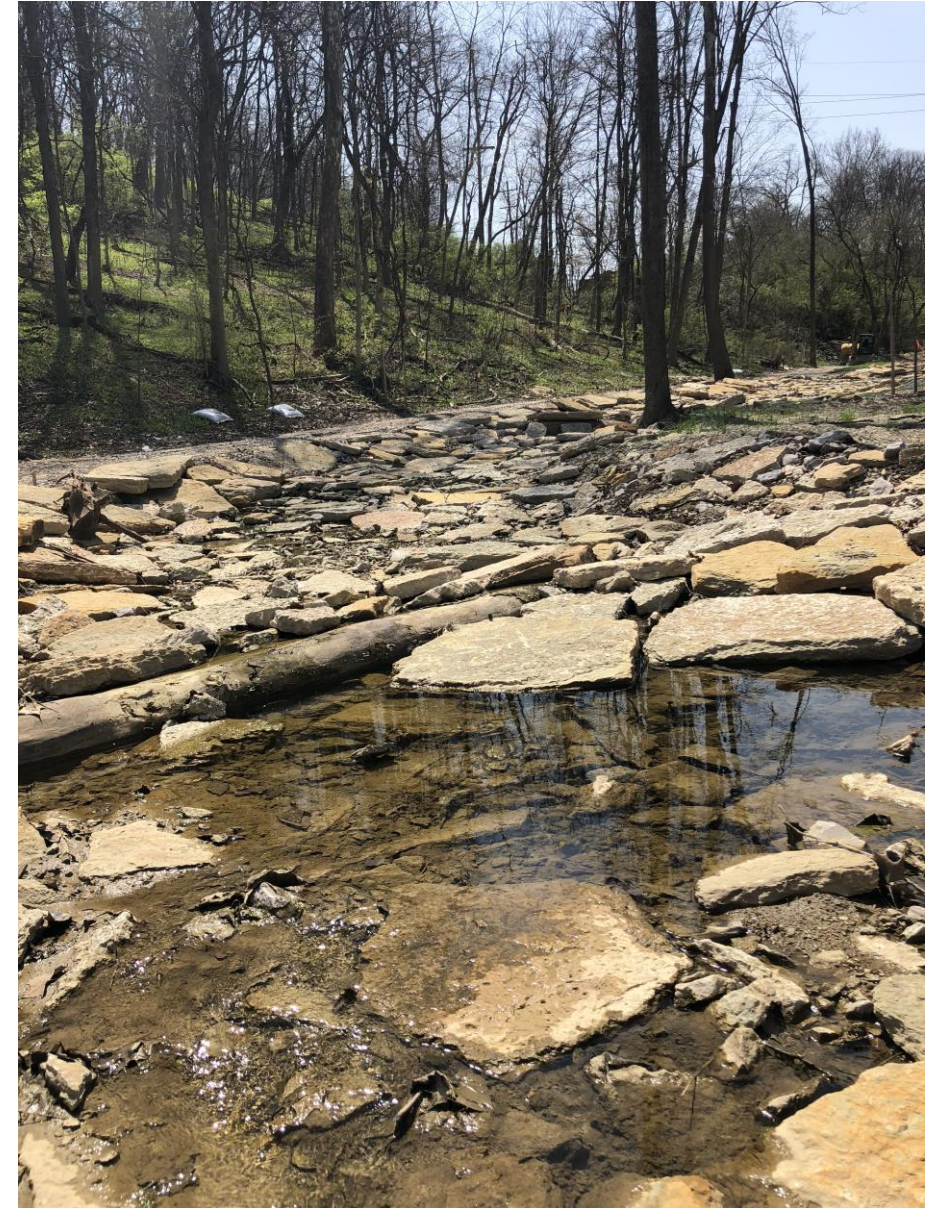
Site Timber Reuse

- Log vanes and large woody debris installed for habitat, water quality, geomorphic and ecological benefits.
- 16 total log vanes installed.

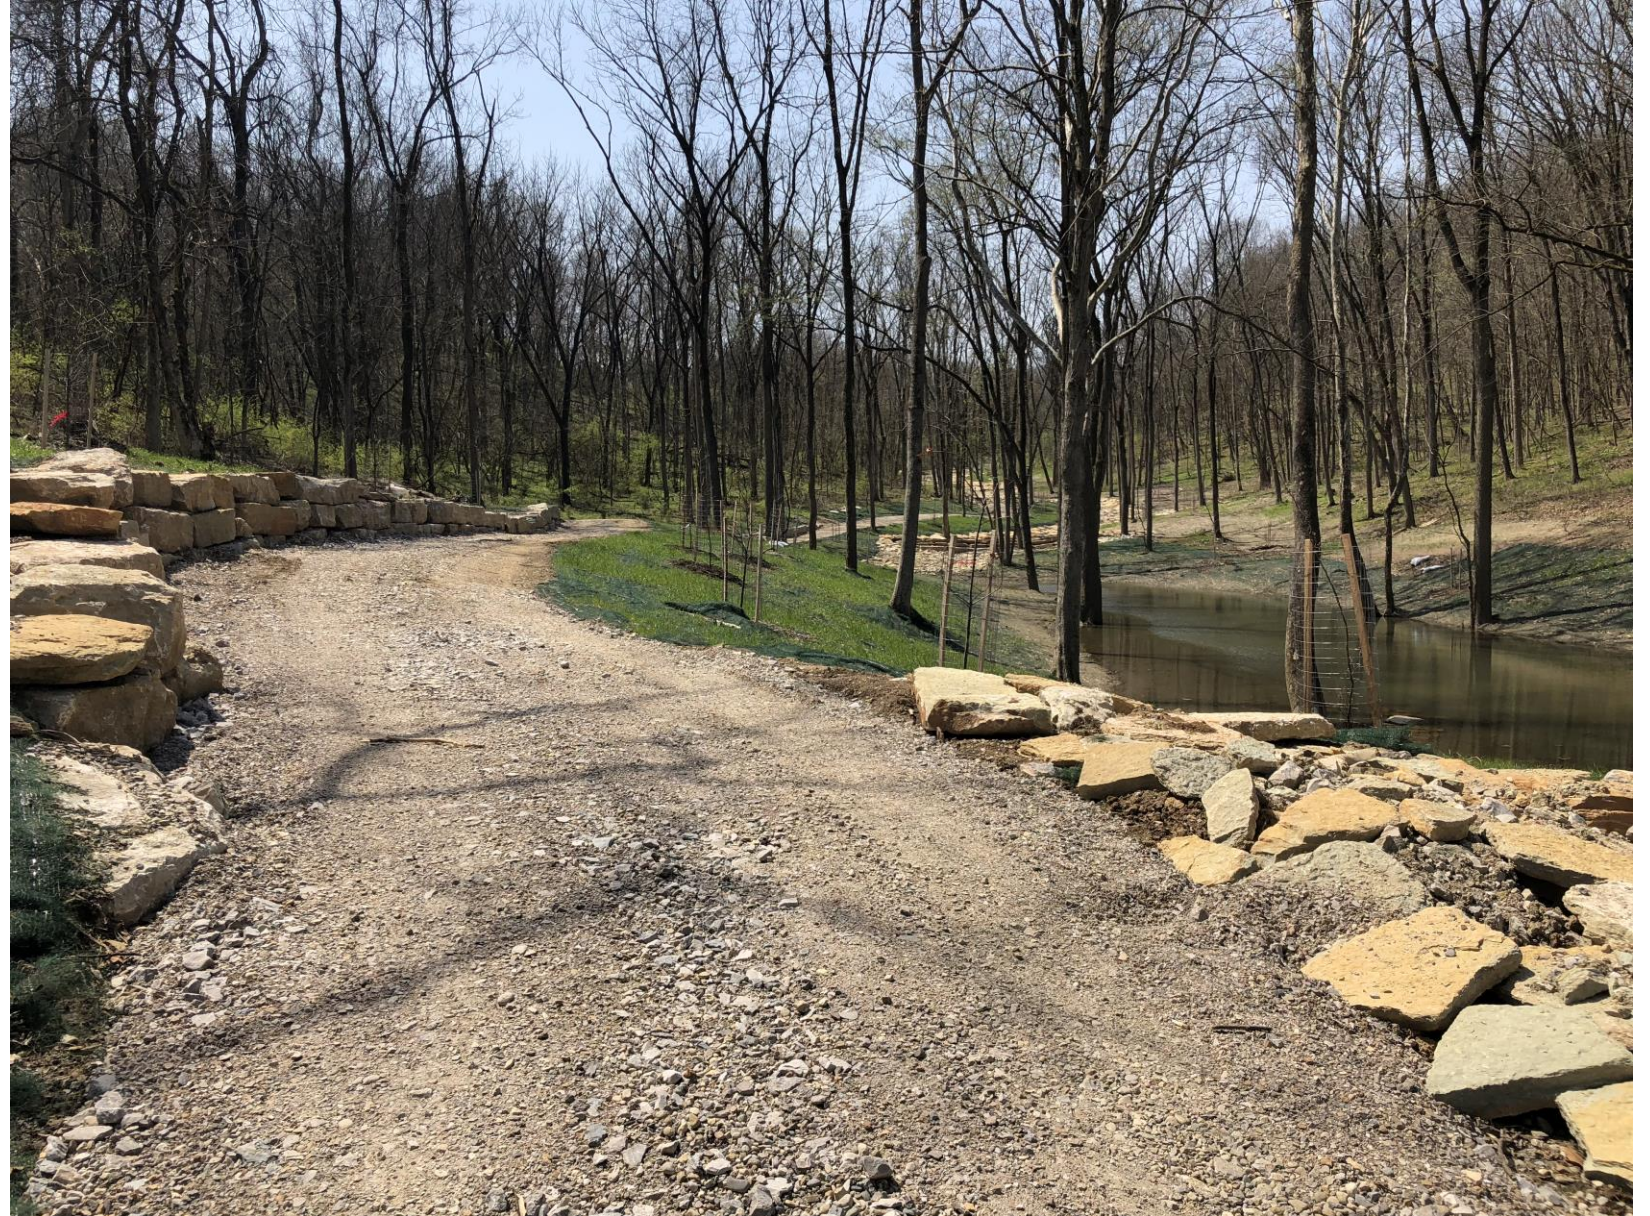
Maintenance Path

- Minimum 8-foot-wide path adjacent to channel
- Potential to be used as a multi-use path

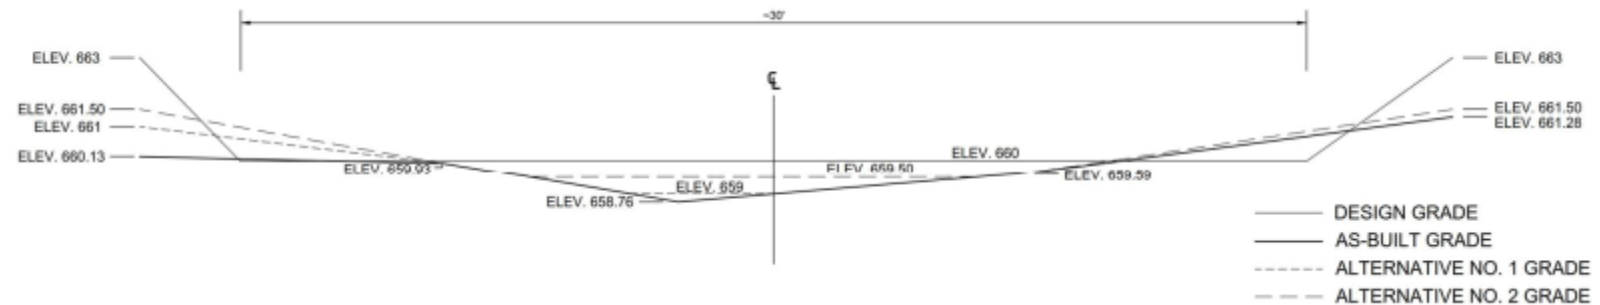
- As constructed, the overflow spillway did not conform to the design to control the 10-year and 25-year design storms
- Two modification alternatives were presented to MSDGC to meet design intent with minimal additional work.
- MSDGC decided on modifying the spillway according to alternative #2

Design	Alt #1	Alt #2
Top Elevation of Spillway (ft)	663.00	661.00	661.50
Spillway Elevation (ft)	660.00	659.00	659.50
10-Year WSE (ft)	658.76	658.97	658.97
25-Year WSE (ft)	659.36	659.52	659.58
10-Year Total Peak Discharge (cfs)	11.79	5.74	5.74
25-Year Total Peak Discharge (cfs)	50.98	56.47	51.84
10-Year Flow Through Spillway (cfs)	0.00	0.00	0.00
25-Year Flow Through Spillway (cfs)	0.00	9.43	0.60

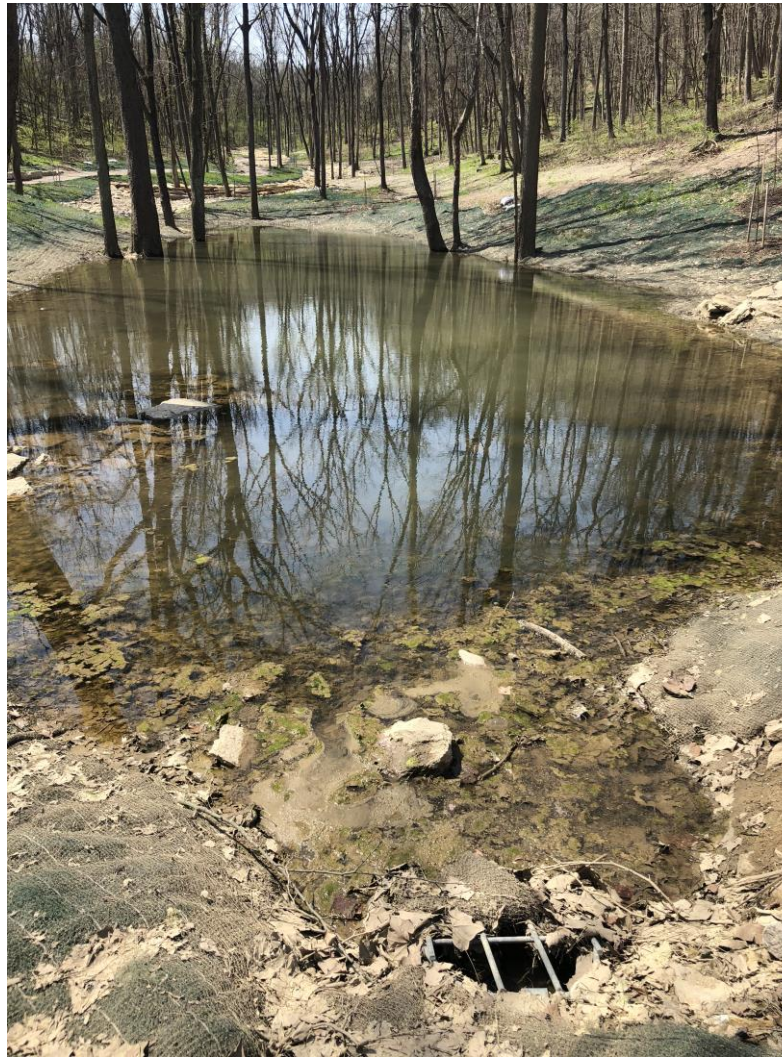
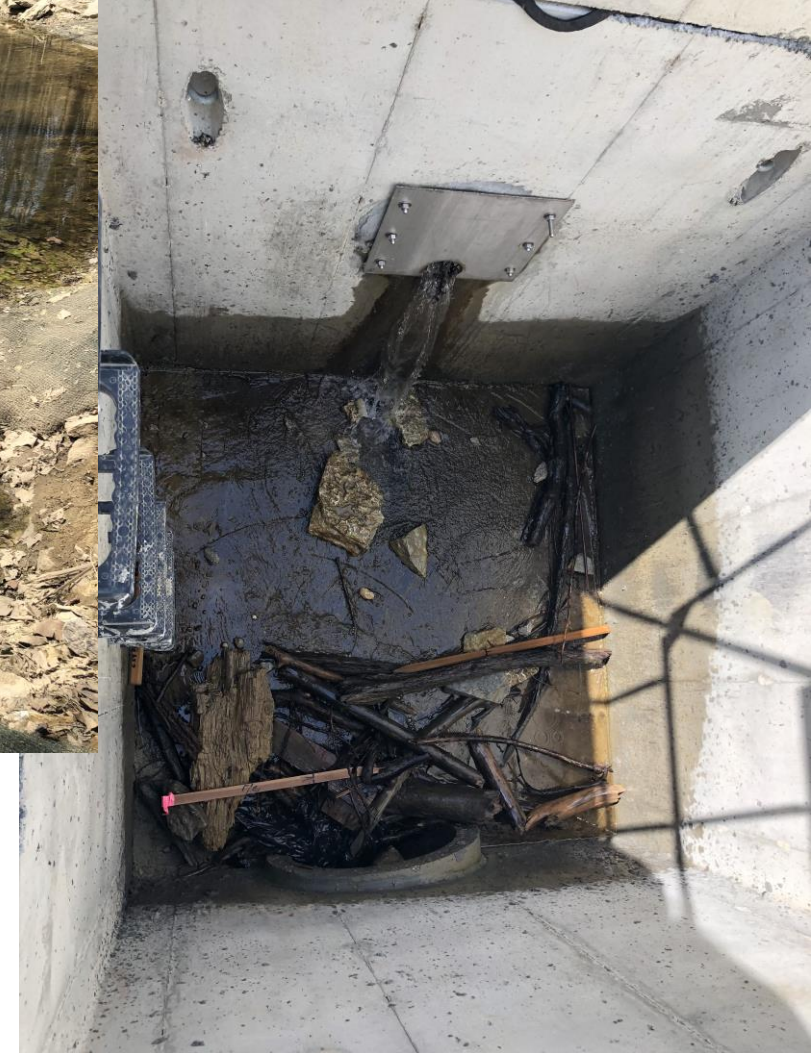
- Detention basin outlet structure clogged with debris.
- Recommendations:
 - Remove trash grate and restrictor plate
 - Install perforated 4" PVC pipe and cleanout
 - Cover pipe with stone to filter out large debris
